**City of Thompson – Wastewater  
Treatment Plant  
Decommissioning Plan**

Decommissioning Plan

April 1, 2022

**Pre-Demolition Hazardous  
Building Materials Assessment**

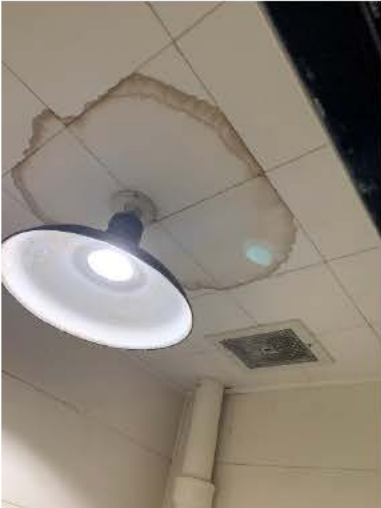
Building Area	Observation	Suspected Source of Moisture	Photo
WWTP washroom	Moisture-stained pressed cardboard ceiling tiles	Roof leaks

When demolition work within the subject buildings proceeds, it is expected that mould and/or moisture impacted building materials will be removed and disposed of during that process. Due to the actual or potential presence of mould on building materials in the building, and if those impacted materials are to be removed by hand, demolition workers should be notified of the potential presence of mould and be provided with respiratory protection and/or other personal protective equipment as deemed necessary for the work that they will be conducting.

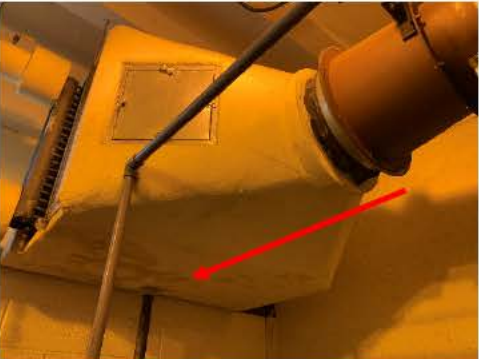
WWTP sludge dewatering room	Moisture-stained duct wrap	Roof leaks; condensation

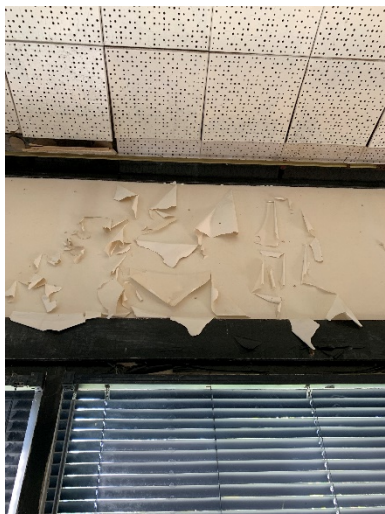
Building Area	Observation	Suspected Source of Moisture	Photo
WWTP office; south wall	Moisture-damaged pressed cardboard ceiling tiles and peeling paint	Roof leaks

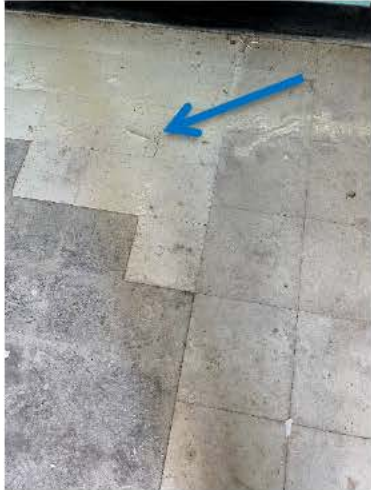
Identified ACM Description and Condition Information							
<p><b>Vinyl floor tile; 9" x 9" beige with grey streaks; located in WWTP office space and hallway</b></p> <table border="1"> <tr> <td>% Type</td> <td>1.5% Chrysotile</td> </tr> <tr> <td>Friability</td> <td>Non-friable</td> </tr> <tr> <td>Condition</td> <td>Good with localized areas of cracked or broken tiles</td> </tr> </table>	% Type	1.5% Chrysotile	Friability	Non-friable	Condition	Good with localized areas of cracked or broken tiles

- Identified ACMs (including damaged materials and/or debris) must be removed prior to building demolition, in accordance with the requirements of MB Reg. 217/2006 and the Asbestos Guide.

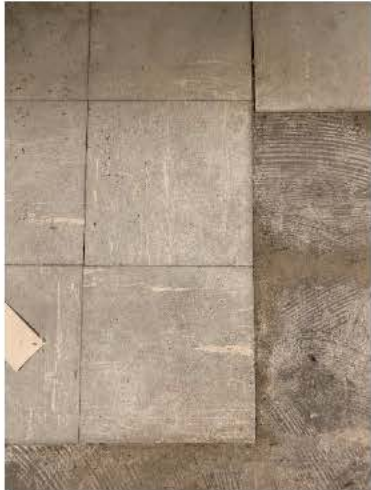
% Type	1.5% Chrysotile						
Friability	Non-friable						
Condition	Good with localized areas of cracked or broken tiles						
<p><b>Vinyl floor tile; 9" x 9" grey with white streaks; located in WWTP laboratory</b></p> <table border="1"> <tr> <td>% Type</td> <td>1.8% Chrysotile</td> </tr> <tr> <td>Friability</td> <td>Non-friable</td> </tr> <tr> <td>Condition</td> <td>Good with localized areas of cracked or broken tiles</td> </tr> </table>	% Type	1.8% Chrysotile	Friability	Non-friable	Condition	Good with localized areas of cracked or broken tiles

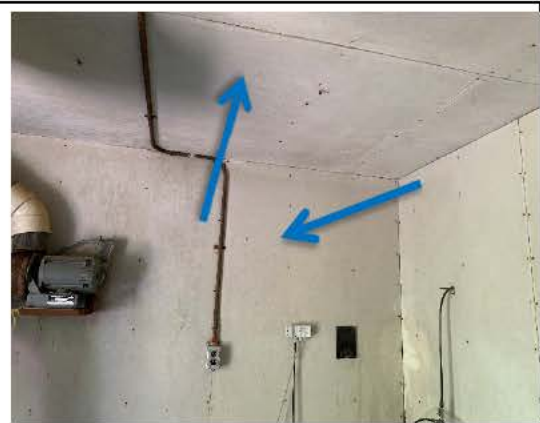
<b>Cement board; chlorination building; interior walls and ceiling</b>	
% Type	13% Chrysotile
Friability	Non-friable
Condition	Good

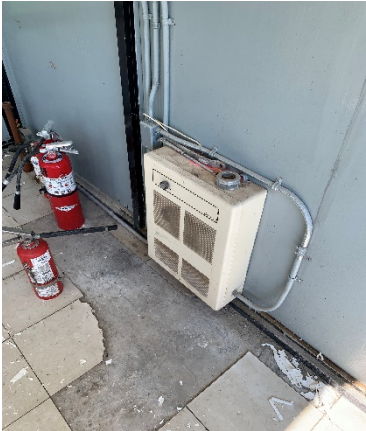
LCP Description		Photo
Paint colour	Blue

Substrate	Plywood	
Location/approx. extent	WWTP; entrance walls	
Lead content	1,000 ppm	
Condition	Good	
Paint colour	Red

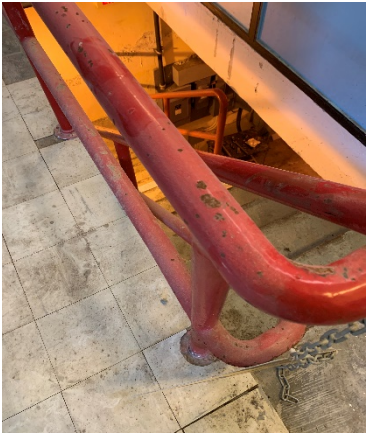
Substrate	Metal	
Location/approx. extent	WWTP; railing to pump floor	
Lead content	1,400 ppm	
Condition	Good	
Paint colour	Orange

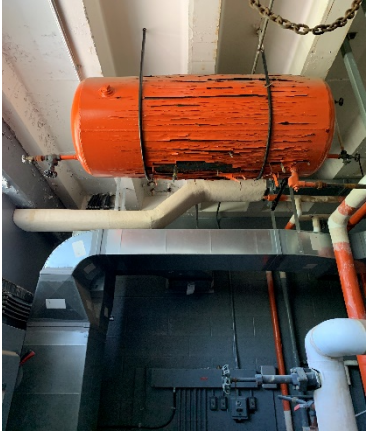
Substrate	Metal	
Location/approx. extent	WWTP; pump, tank and associated piping in boiler room	
Lead content	57,000 ppm	
Condition	Poor

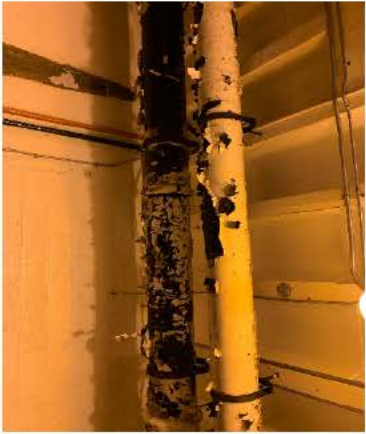
Paint colour	White

Substrate	Metal	
Location/approx. extent	WWTP; piping on pump room floor	
Lead content	1,000	
Condition	Poor	
Paint colour	Rust

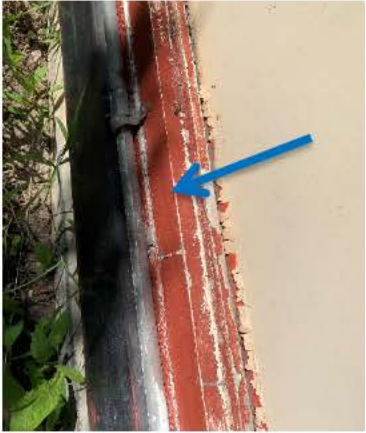
Substrate	Metal	
Location/approx. extent	WWTP; exterior trim	
Lead content	5,500 ppm	
Condition	Good	
Paint colour	Black

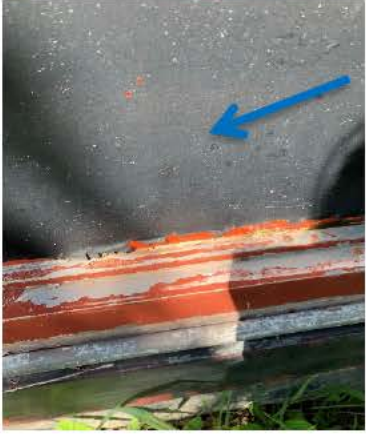
Substrate	Metal	
Location/approx. extent	WWTP; exterior panels	
Lead content	2,900 ppm	
Condition	Good

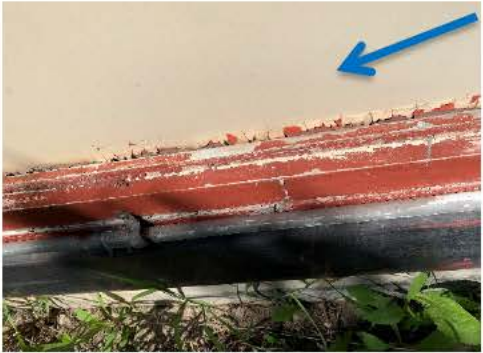
Paint colour	Beige

Substrate	Metal	
Location/approx. extent	WWTP; exterior panels	
Lead content	3,000 ppm	
Condition	Good	
Paint colour	Brown

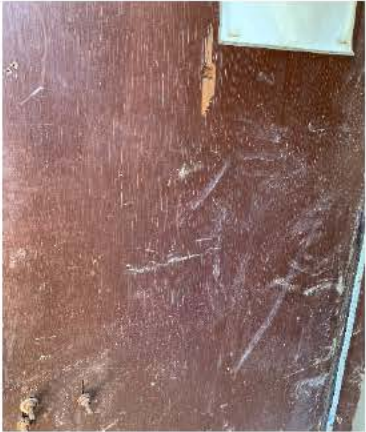
Substrate	Wood	
Location/approx. extent	Chlorination building; exterior door	
Lead content	9,100 ppm	
Condition	Good
