MINE CLOSURE PLAN

RE: Tanco Mine Closure Plan (Revision 4)

Re: TANCO Mine Closure Plan, Revision 4

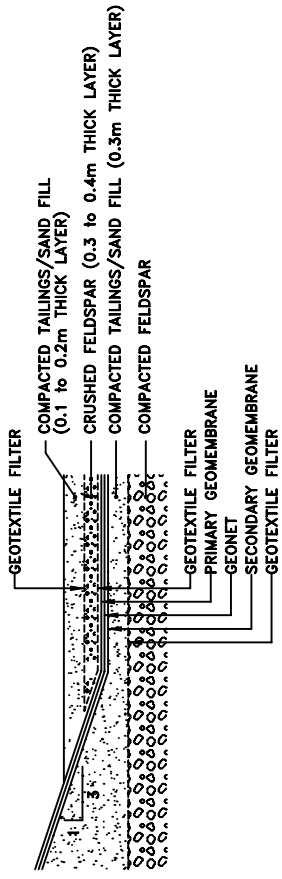
4 DETAIL — LINER AND CELL BOTTOM
SCALE 1:50
C004/C005

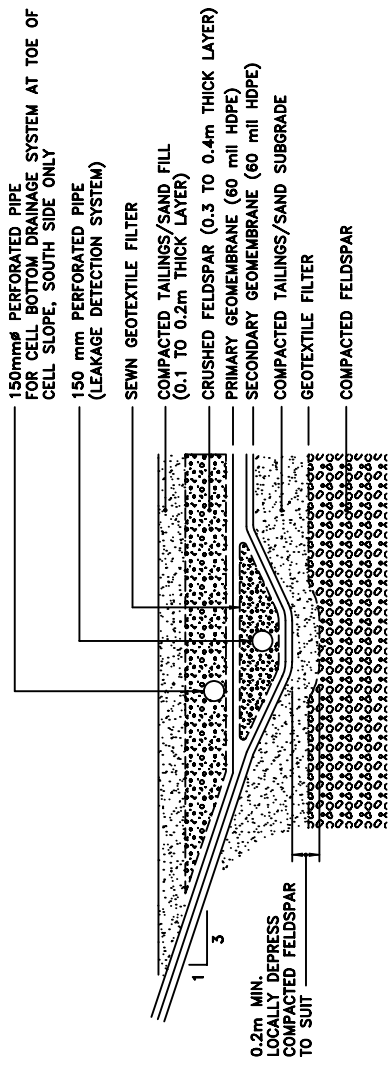
5 DETAIL — CELL BOTTOM DRAINAGE SYSTEM
SCALE 1:50
C004/C005

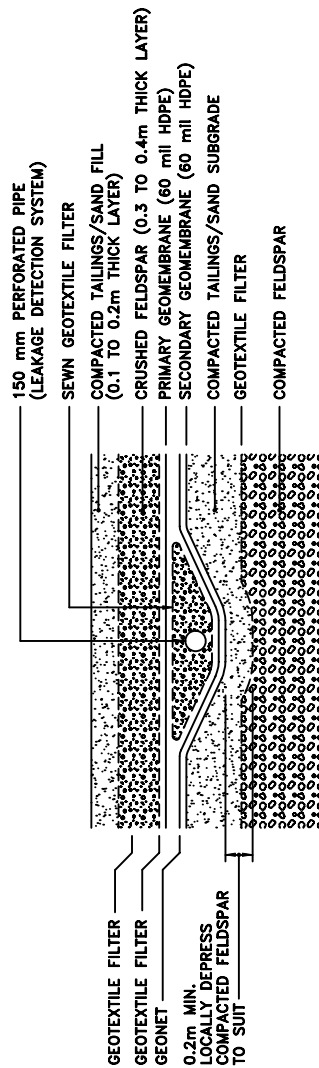
6 DETAIL — LEAKAGE DETECTION SYSTEM
SCALE 1:50
C004/C005

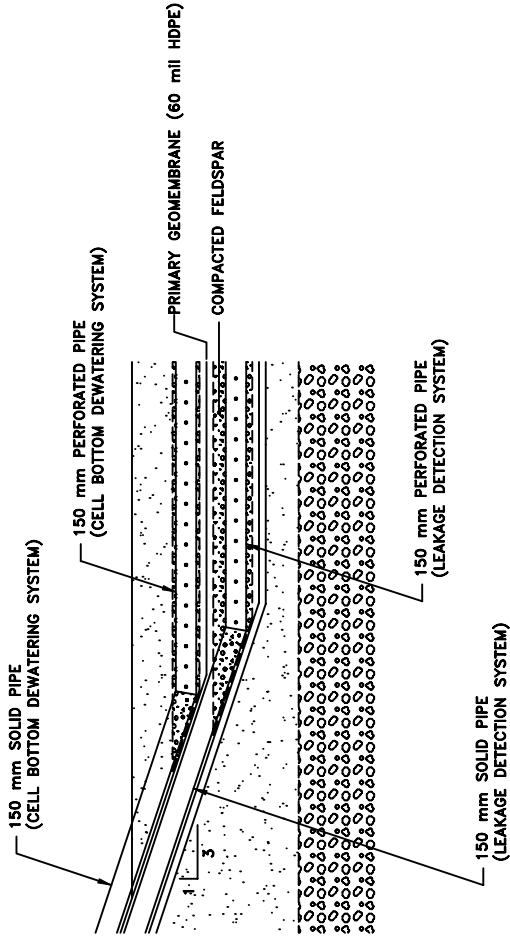
7 DETAIL — PIPING
SCALE 1:25
C004/C005

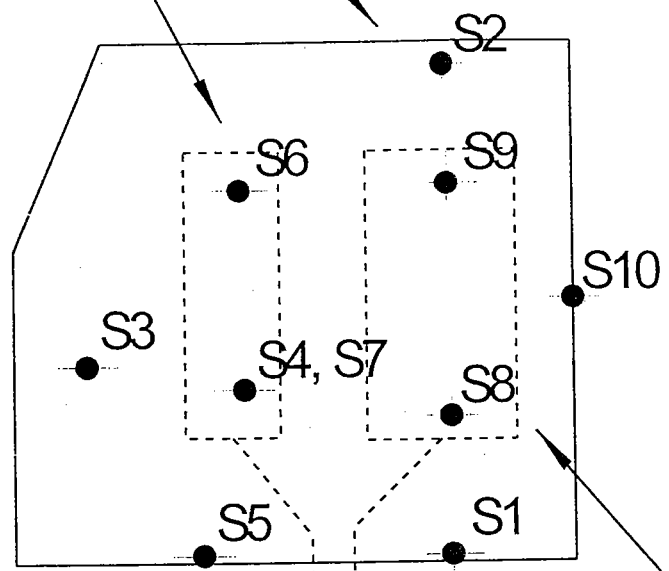
Former location of 6000 gallon gasoline UST

Excavation limits

Former underground fuel lines

Former location of 2000 gallon diesel fuel UST

The field investigation was conducted by NTL field personnel on May 29, 2001. Soil excavation and tanks removal were performed under the supervision of Beaver Pump Service (1988) Ltd. which commenced after a short safety meeting. The 1000 gallon gasoline UST, removed first, was empty of product prior to removal and was slightly rusted but had no visible holes or perforations. After removal, the tank was purged of hydrocarbon vapours using a portable air compressor. The 2000 gallon diesel fuel UST was pumped out by A-1 Environmental Services prior to removal and was found to be slightly rusted but had no visible holes or perforations.

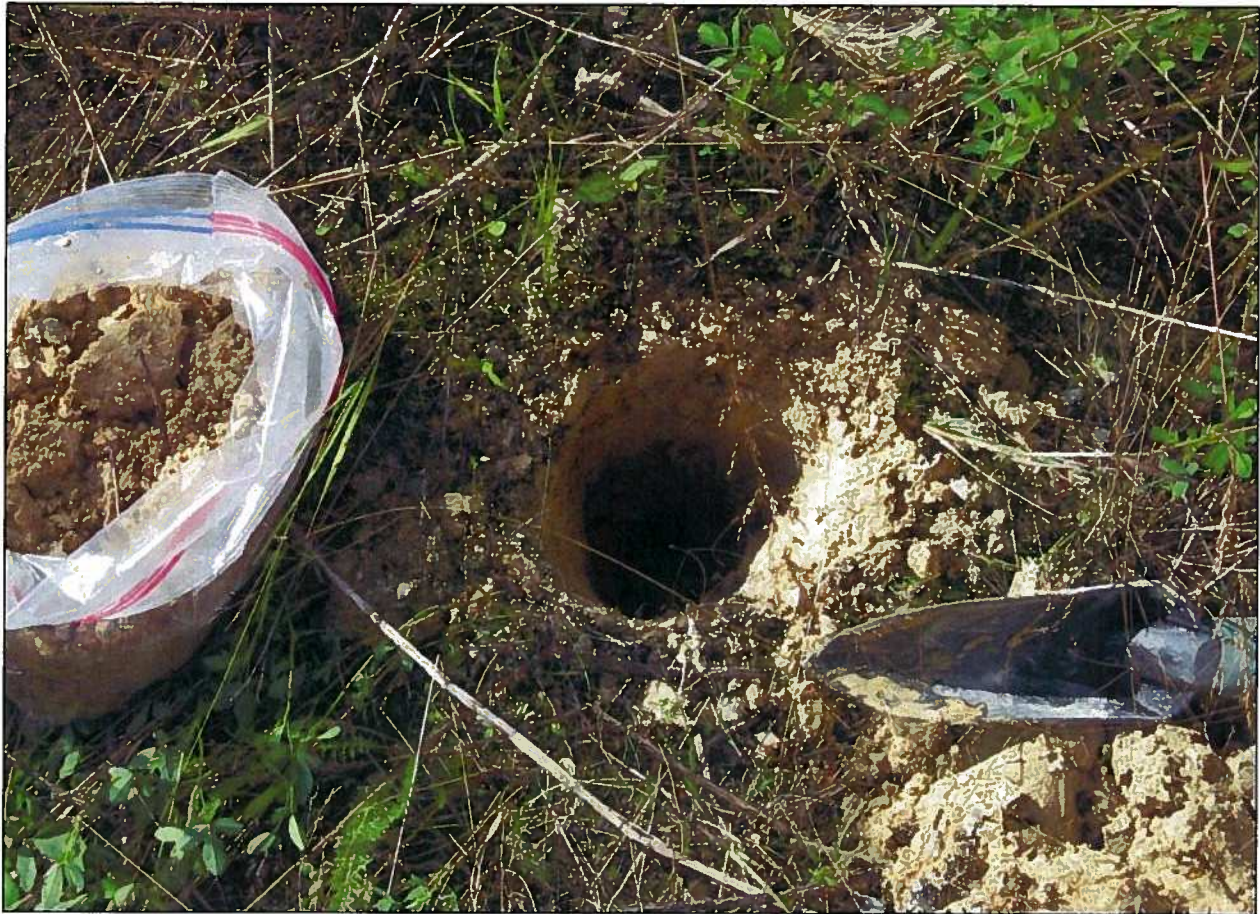
Figure 4: TRY soil profile.

An organic soil horizon develops on the surface of tailings as a result of the accumulation of plant litter. The organic soil horizon stabilises disturbed surface soils (Beyers, 2004). The depth of the organic layer was 3 cm in both TRO2 and TRO3 (Old Vegetation Areas No. 2 and No. 3) (Figure 10 and 12). The depth of organic layer in TRO3 (Old Vegetation Area No. 1) varied from 0 to 2 cm. One centimetre of organic matter was measured in TRI (Intermediate Vegetation Area). No organic layer was observed in TRY (Young Vegetation Area), although there was 1 mm of moss cover (Figure 4). No organic matter accumulation was found on the CPF Residue study plot (Figure 13).

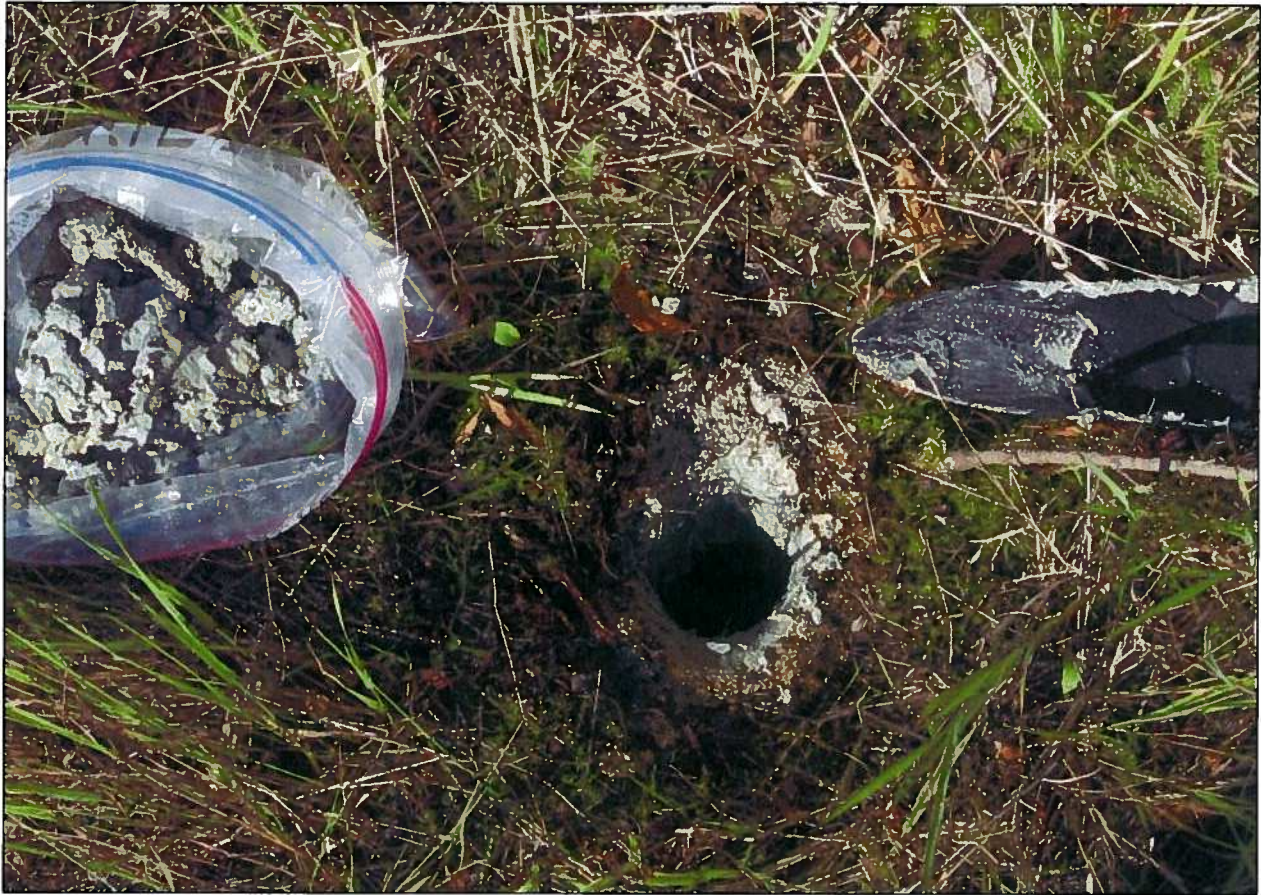
Figure 6: TRI soil profile.

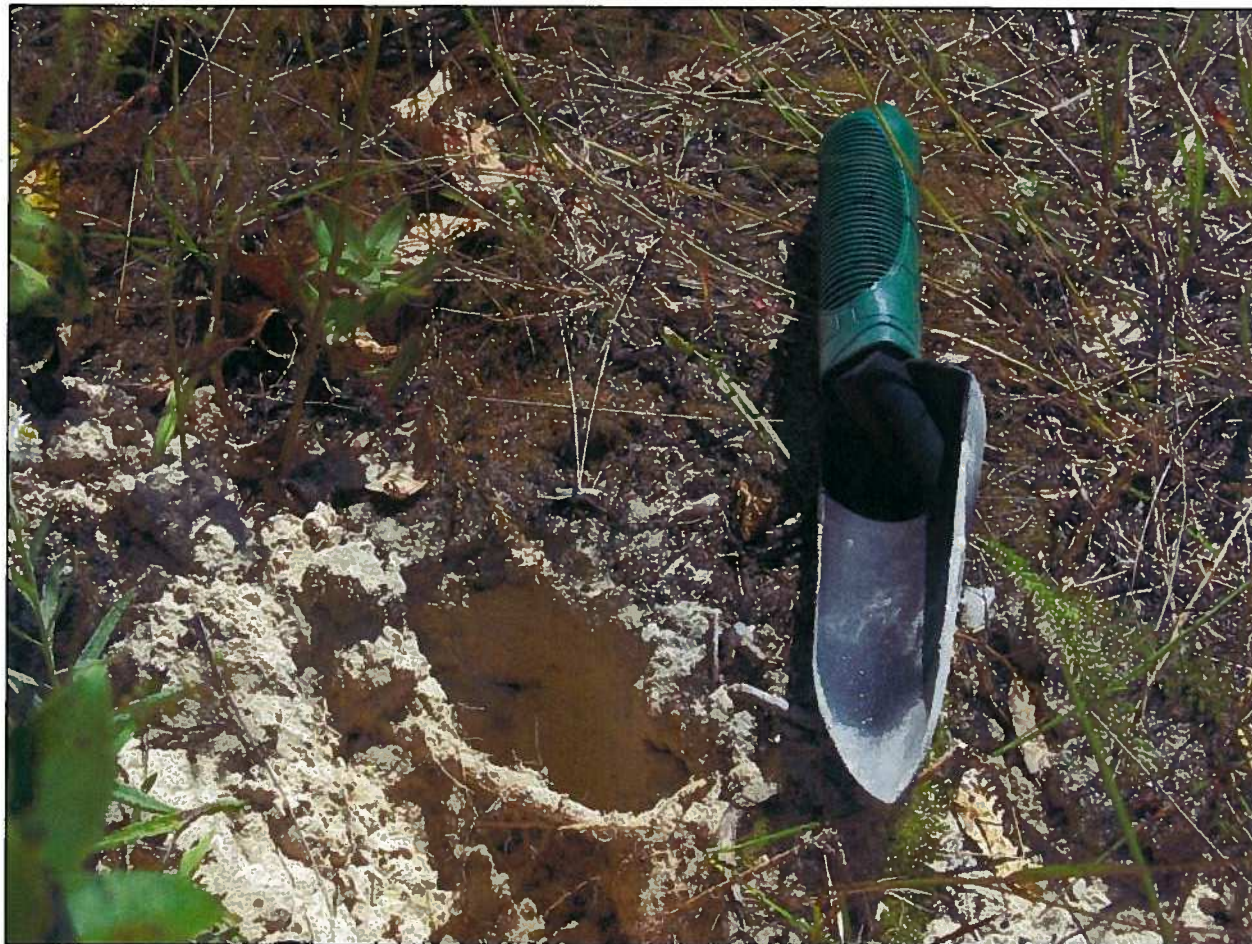
Figure 8: TRO1 soil profile.

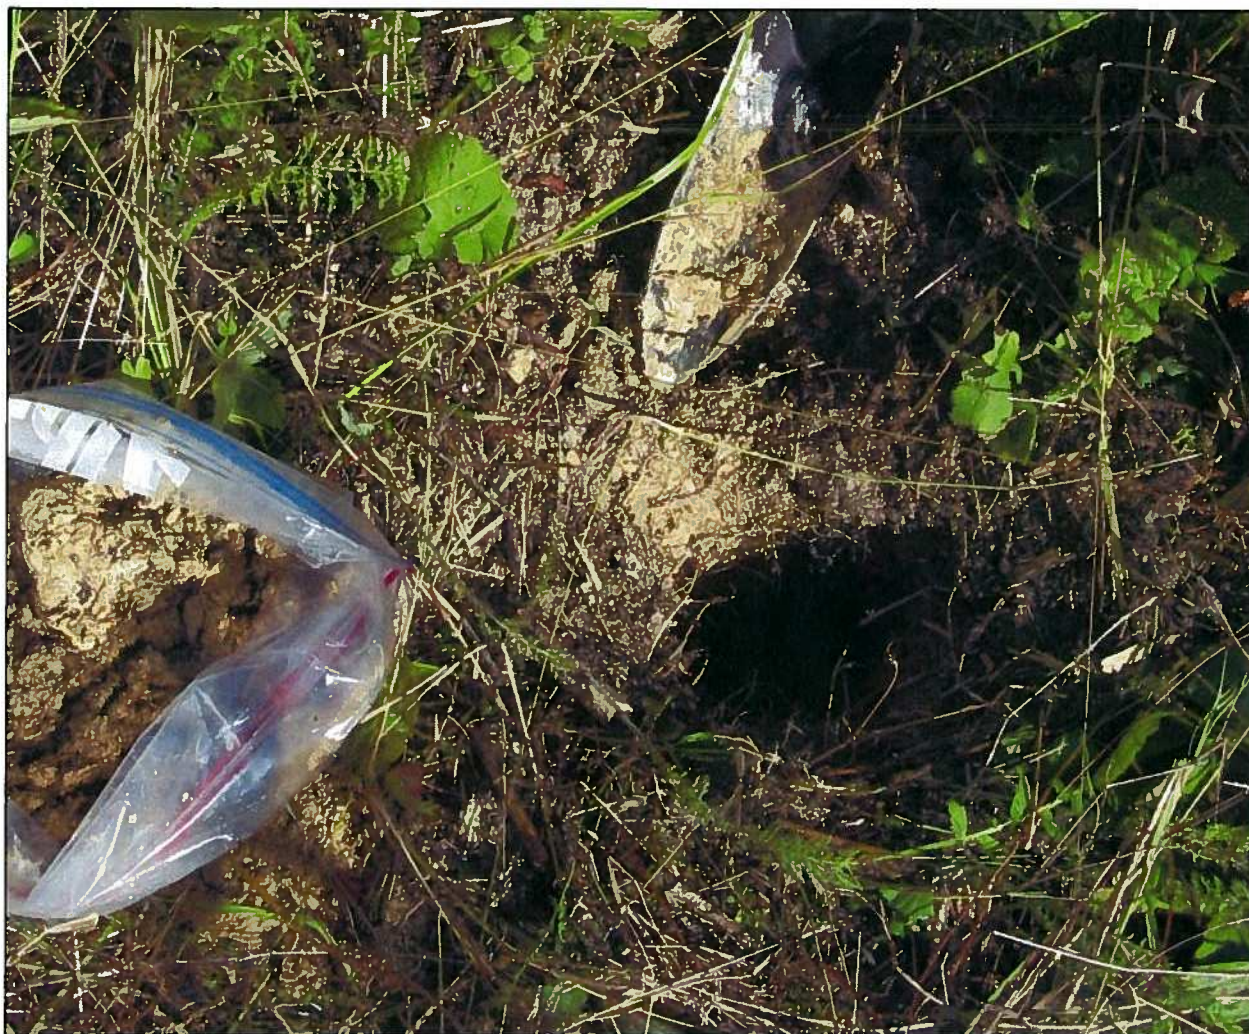
Figure 10: TRO2 soil profile.

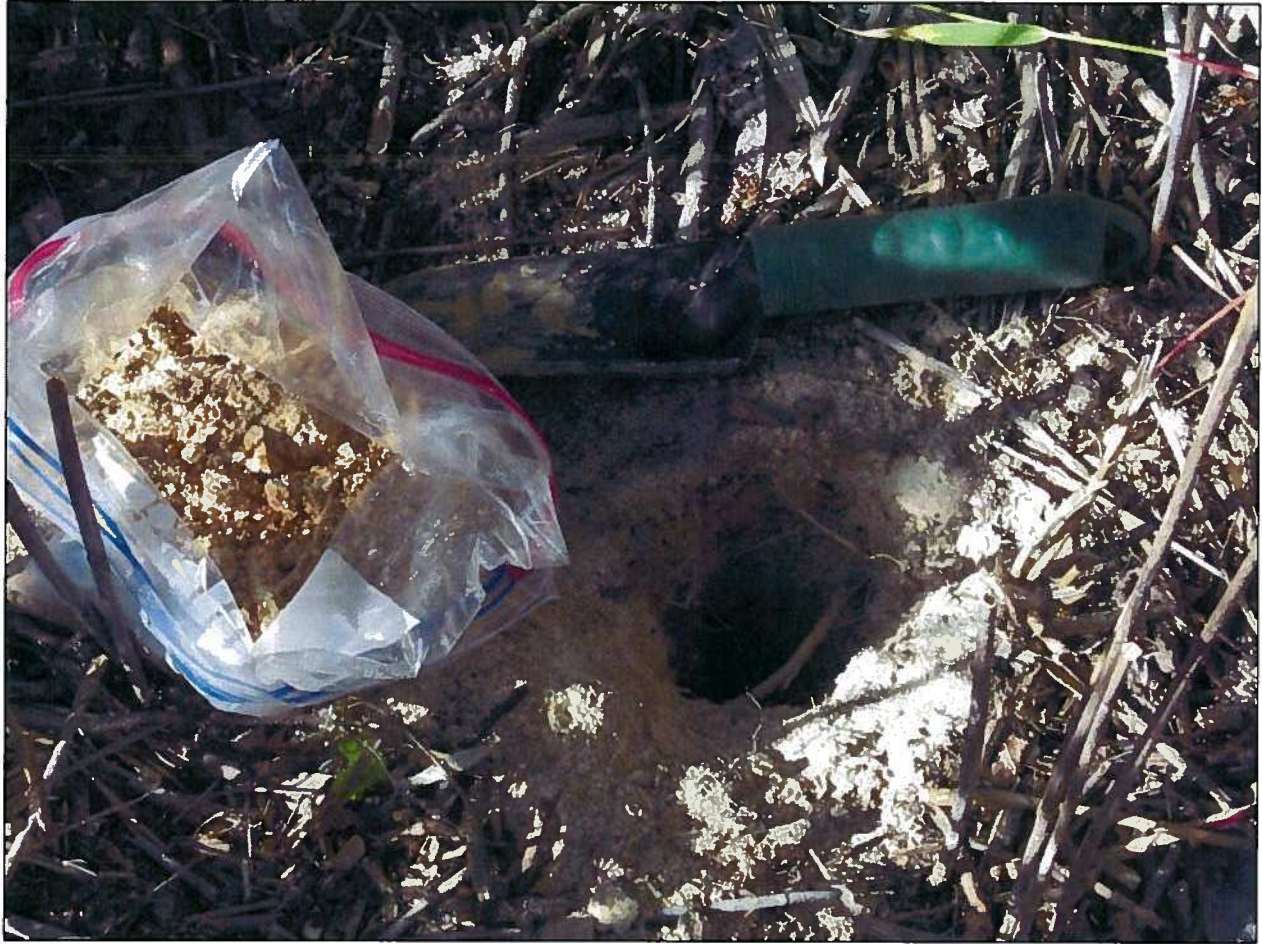
Figure 12: TRO3 soil profile.
