Project No. 20-142-01

RE: Hydraulic Conductivity Test Results, RC3 Repository Construction, NE-02-03-1E,
South of St. Jean Baptiste, Manitoba

**TABLE 1
HYDRAULIC CONDUCTIVITY TEST DATA
RC3 REPOSITORY CONSTRUCTION**

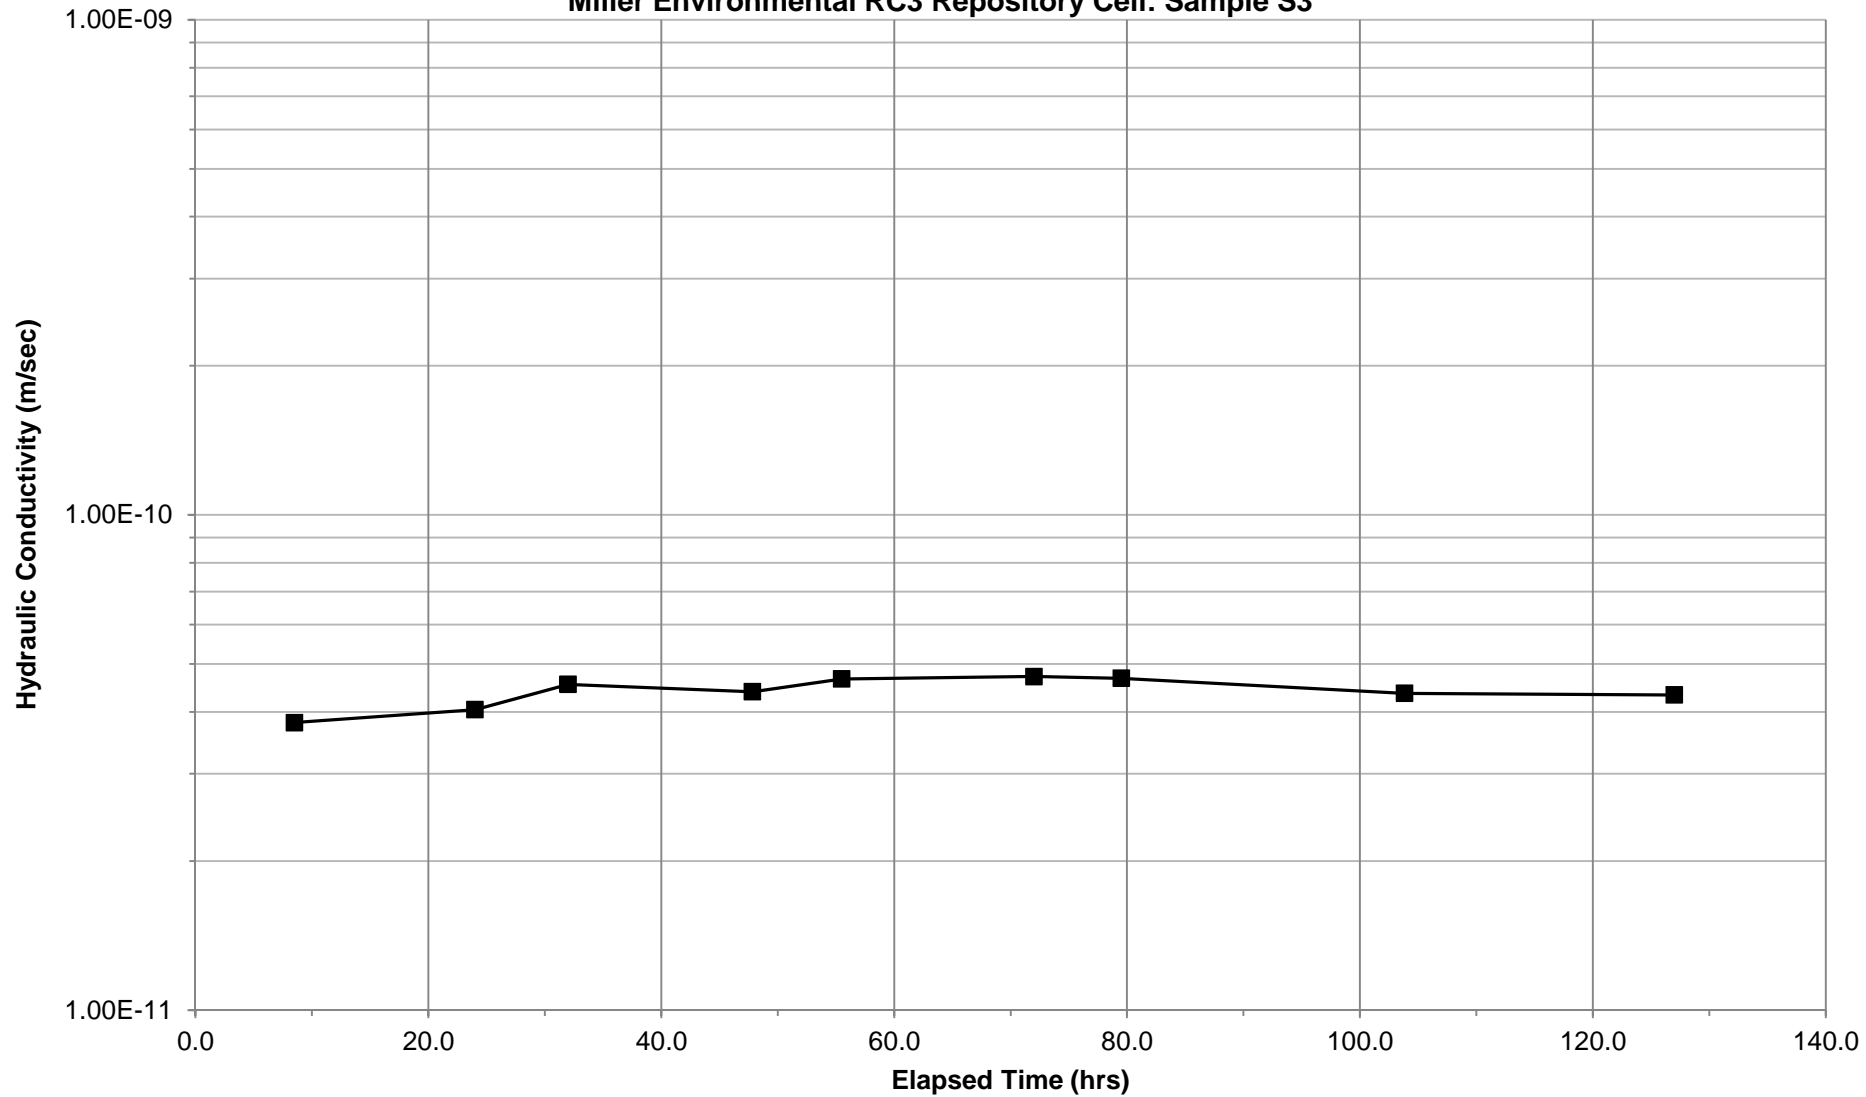
Chart 1: Hydraulic Conductivity Versus Elapsed Time
Miller Environmental RC3 Repository Cell: Sample S3

Three (3) hydraulic conductivity tests were performed on samples S3, S5 and S6, which were selected by Manitoba Conservation. The final hydraulic conductivity values (k_{20}) of these samples ranged from 4.13×10^{-9} to 8.70×10^{-9} cm/sec. The hydraulic conductivity test data is summarized in Table 1, while the graphical representations of the hydraulic conductivity versus elapsed time are shown in Charts 1 to 3. Photographs of the sampling and samples are attached. Shelby tube sample locations are presented on Figure 1.

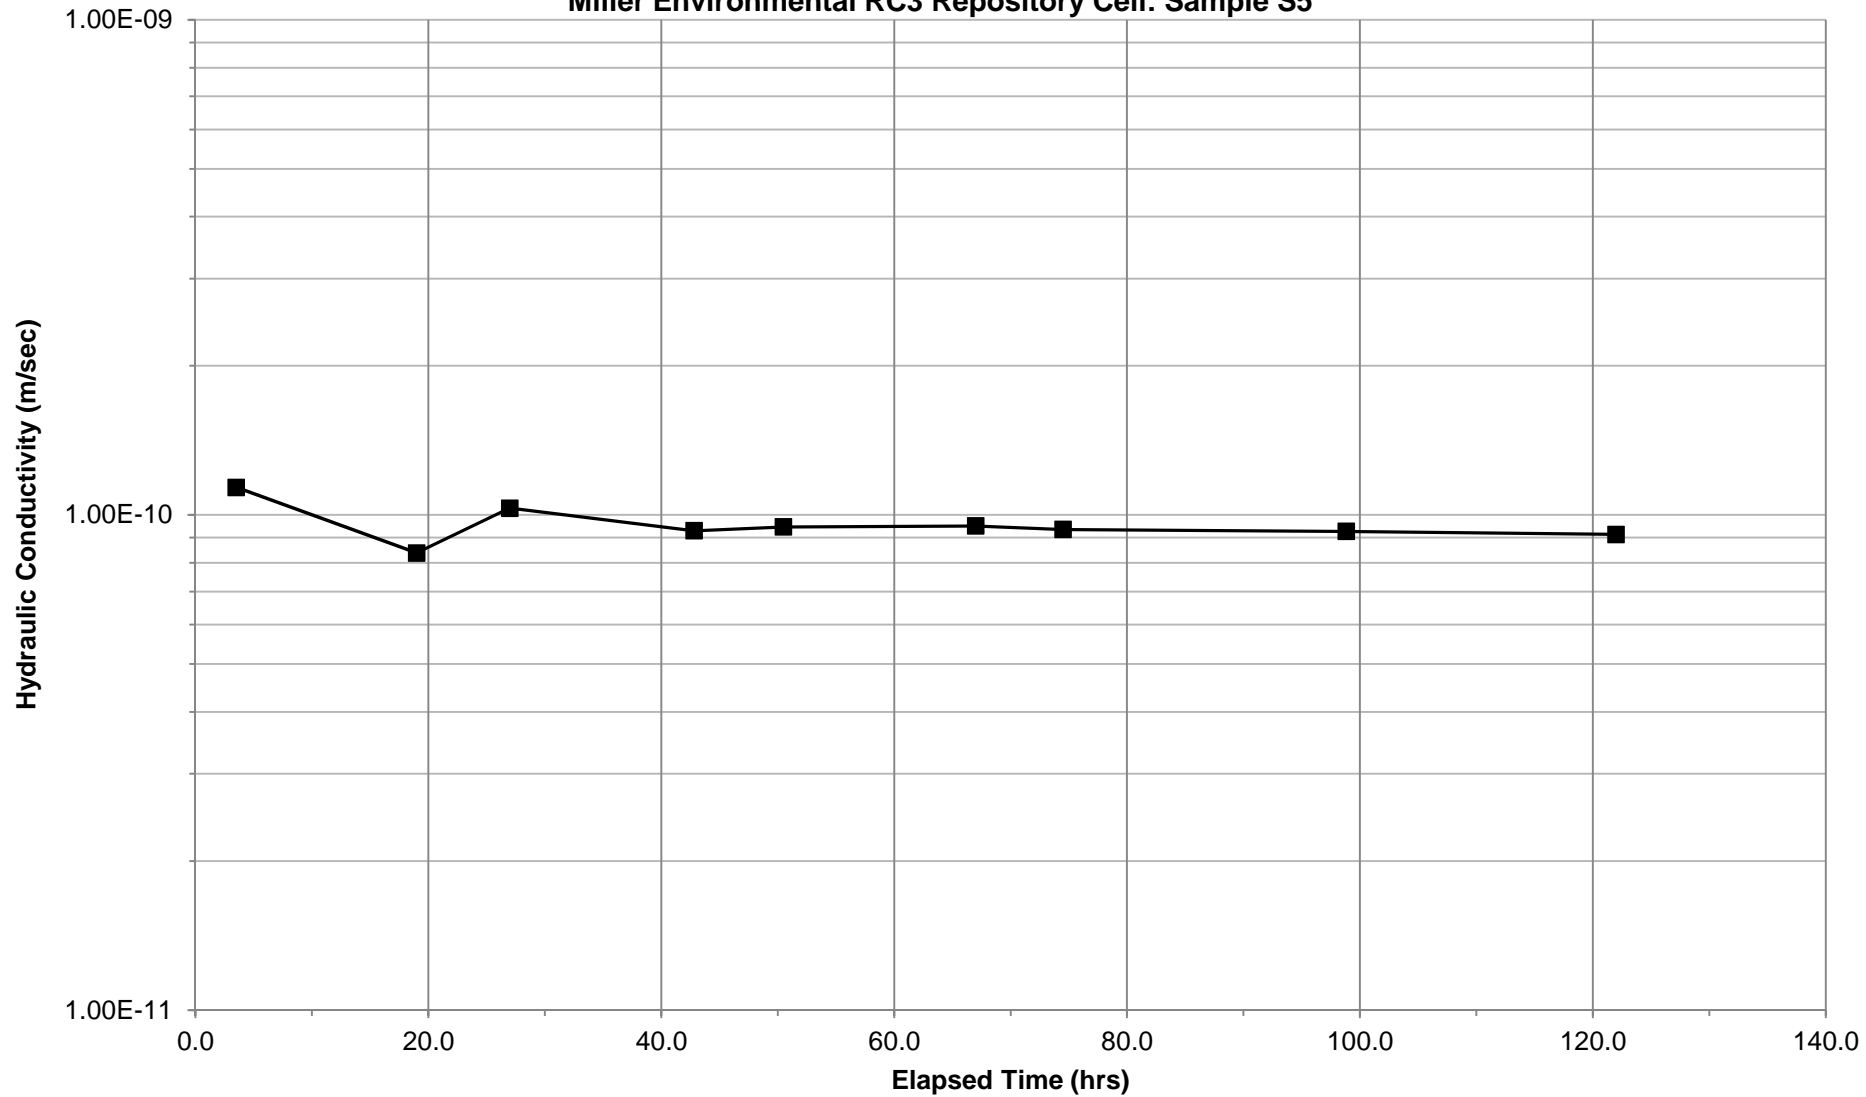
Chart 2: Hydraulic Conductivity Versus Elapsed Time
Miller Environmental RC3 Repository Cell: Sample S5

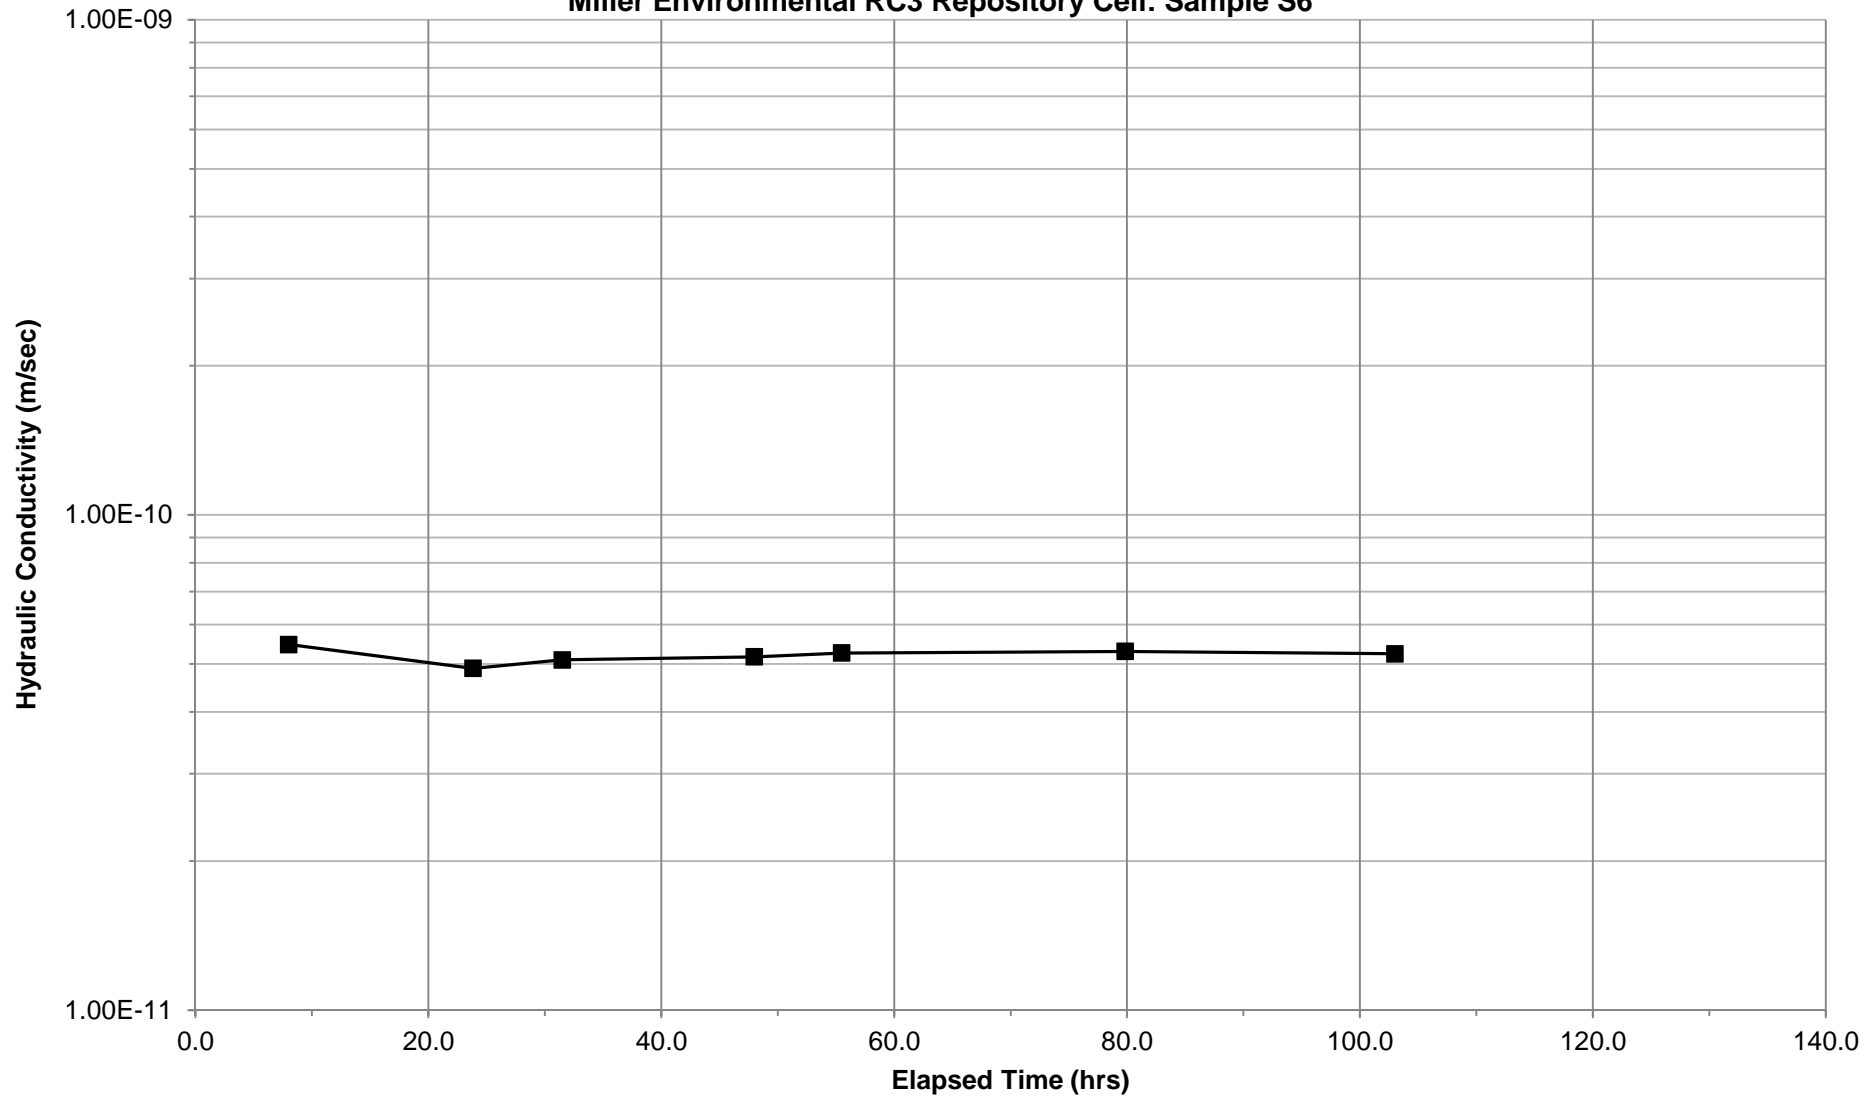
Chart 3: Hydraulic Conductivity Versus Elapsed Time
Miller Environmental RC3 Repository Cell: Sample S6

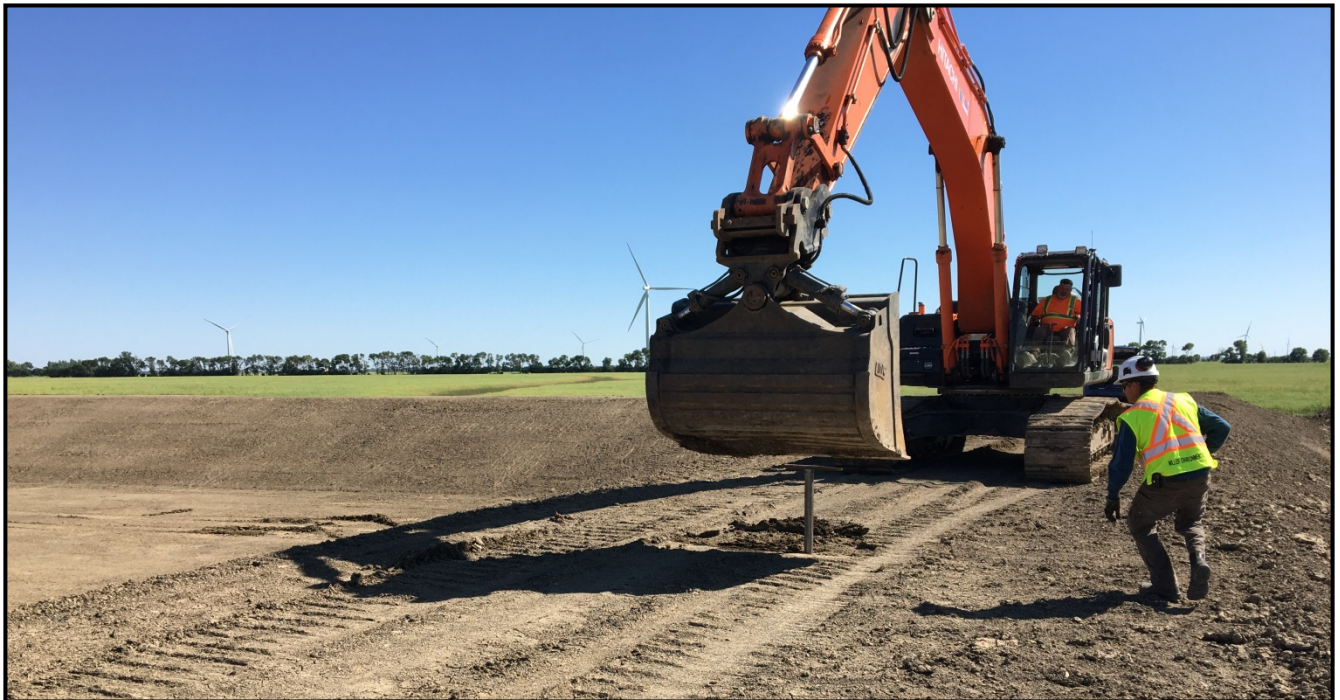
PHOTOGRAPH #2: Collecting the Shelby tube sample at location S6.

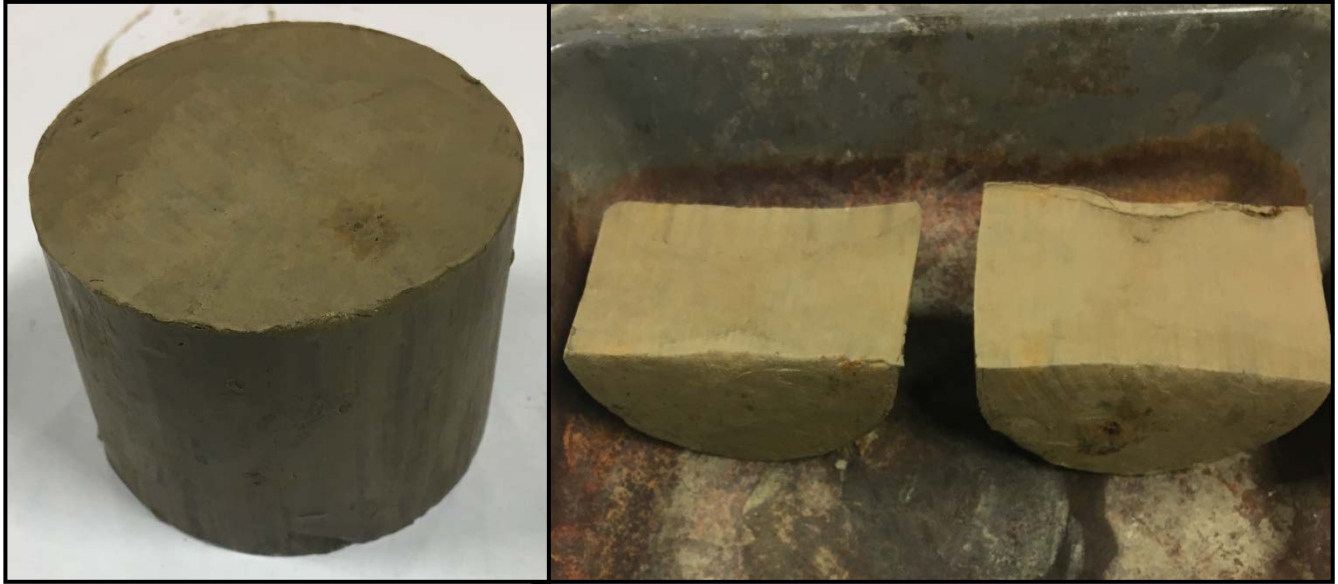
PHOTOGRAPH #3: Sample S3 after hydraulic conductivity testing.

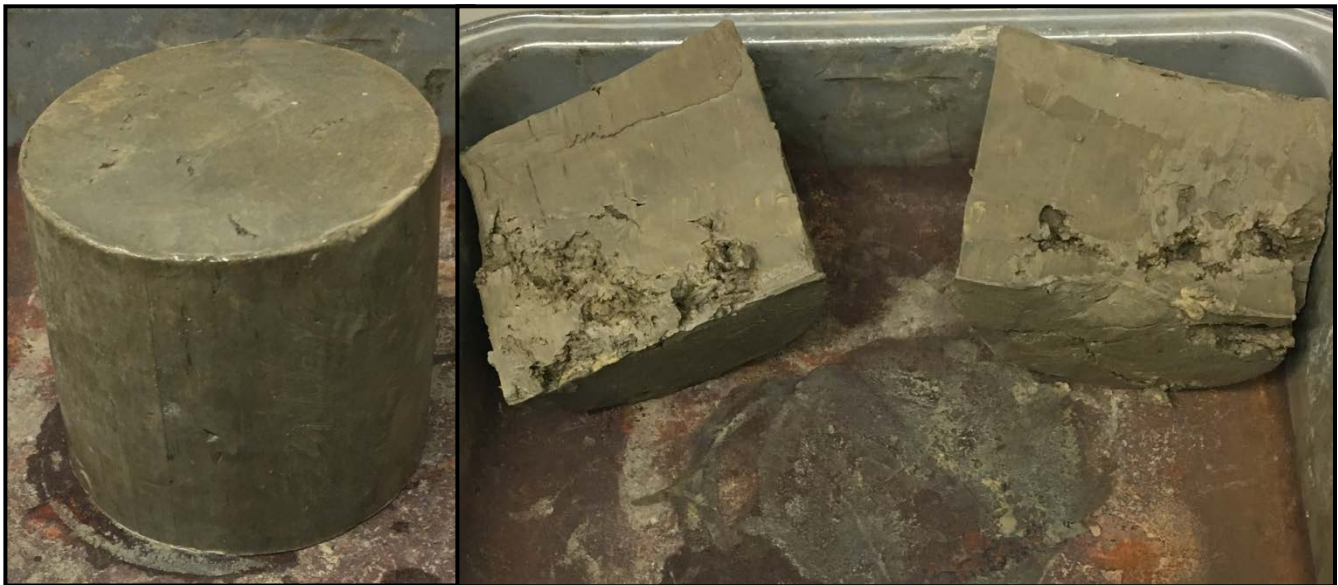
PHOTOGRAPH #4: Sample S5 after hydraulic conductivity testing.

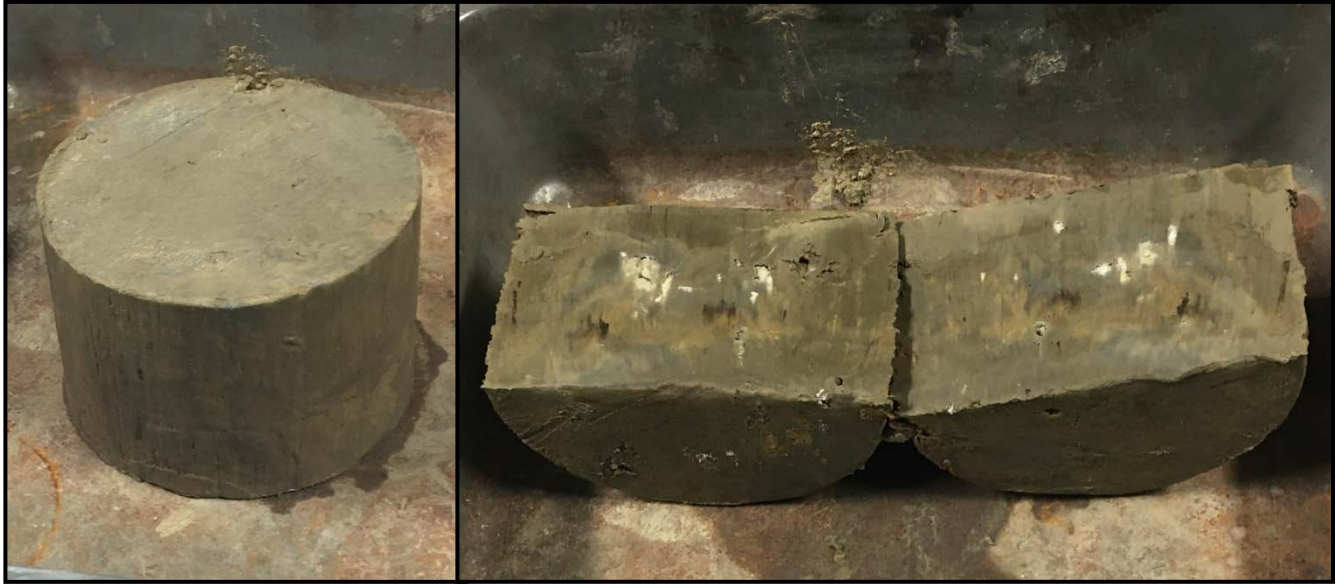
PHOTOGRAPH #5: Sample S6 after hydraulic conductivity testing.

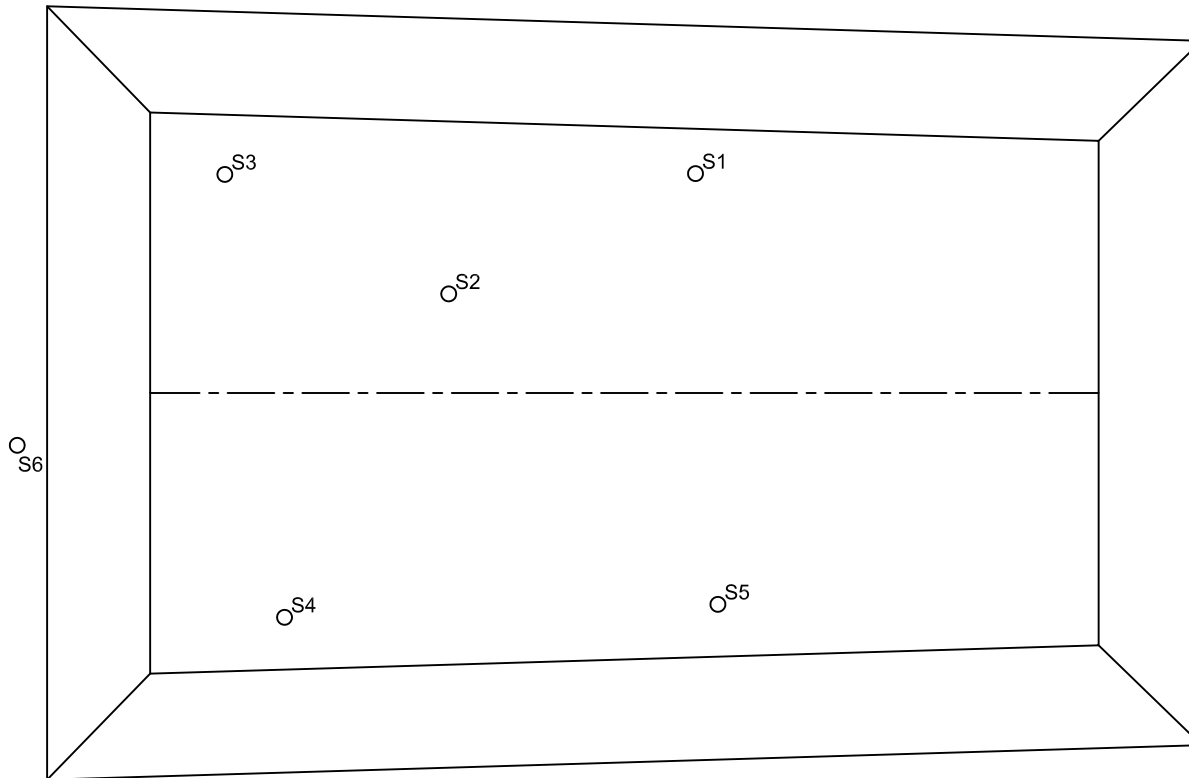
ENG-TECH DWG/FIG. No.: 1	NO.: 0
-----------------------------	-----------

DWG DESCRIPTION:
SHELBY TUBE SAMPLE LOCATIONS
