Figure 1. The Lalor Lake Study Area.

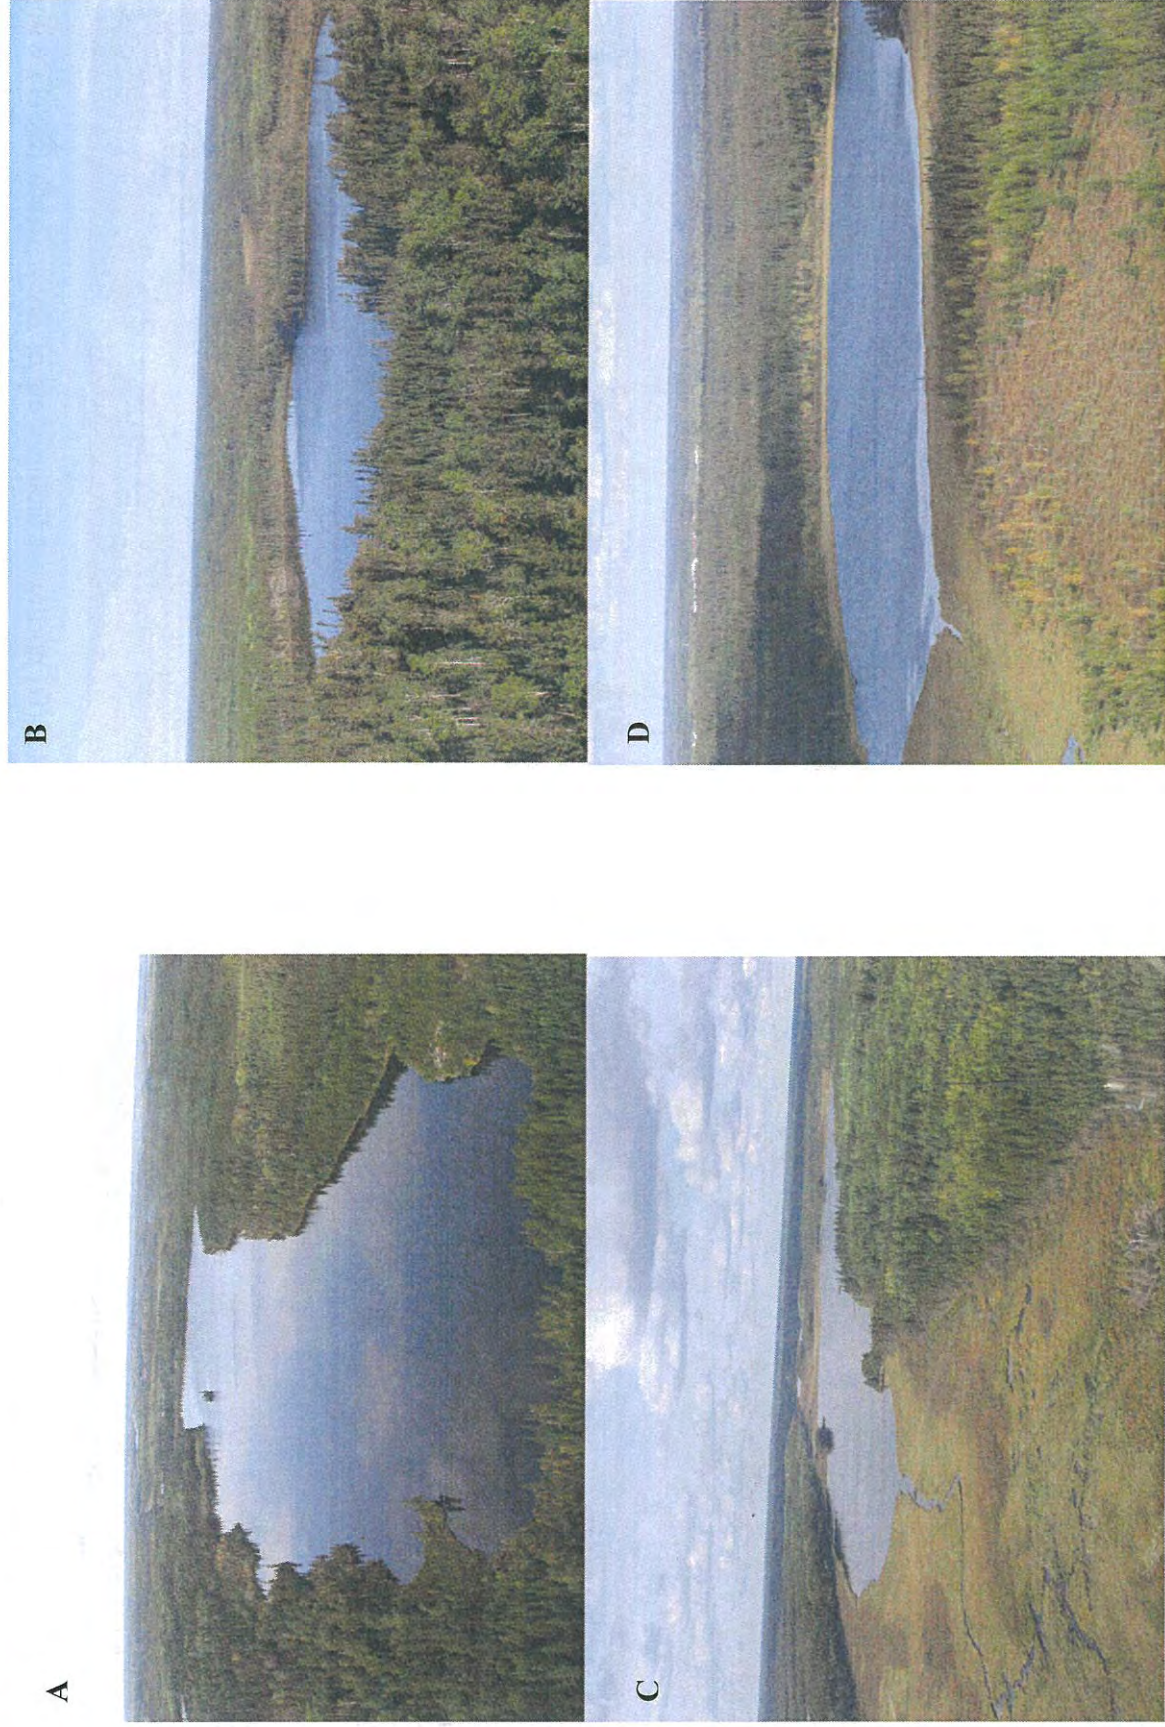
Figure 2. North facing view of: (A) Lalor Lake; (B) Maw Lake; (C) Varnson Lake; and (D) east facing view of Tern Lake.

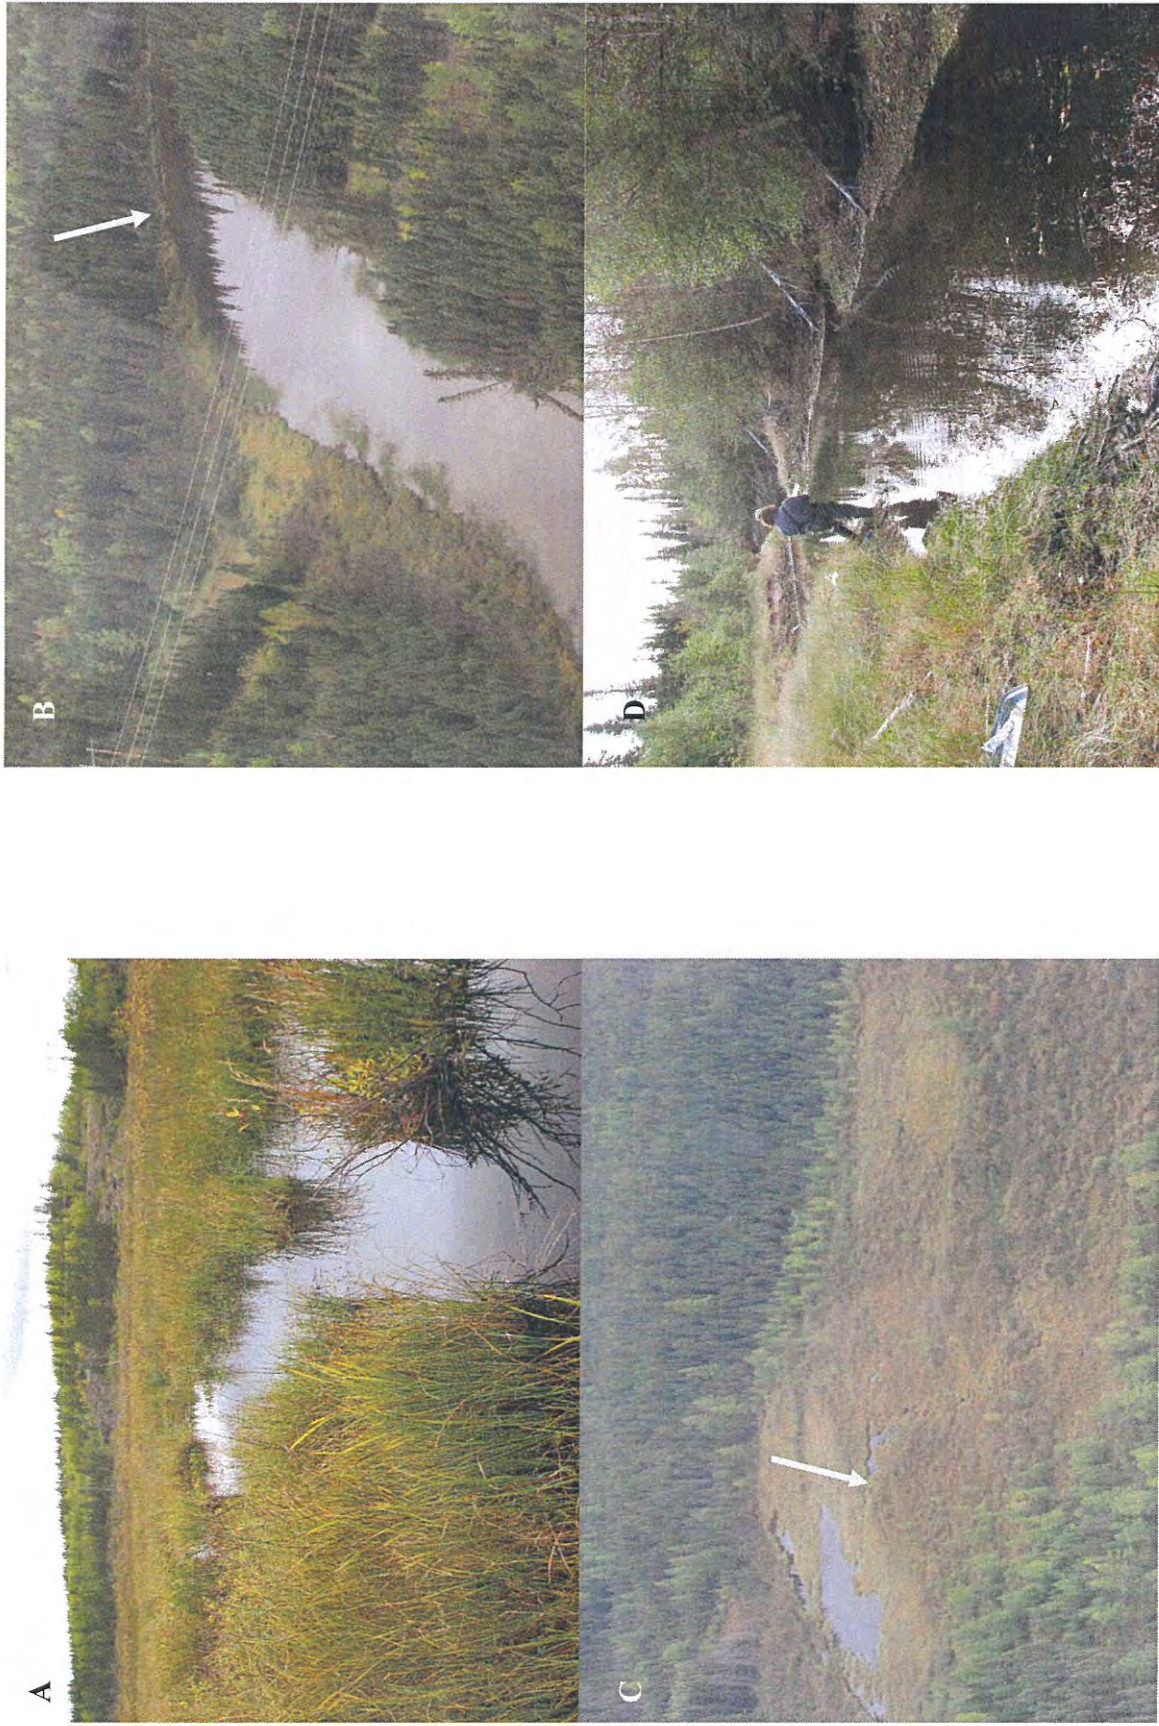
Figure 3. (A) southwest facing view of Unnamed Creek 1 at sampling site, (B) northwest facing view of Snow Creek (SC-1) with arrow pointing to sampling site, (C) east facing view of Tern Creek with arrow pointing to sampling site, and (D) south facing view of Tern Ditch at sampling site.

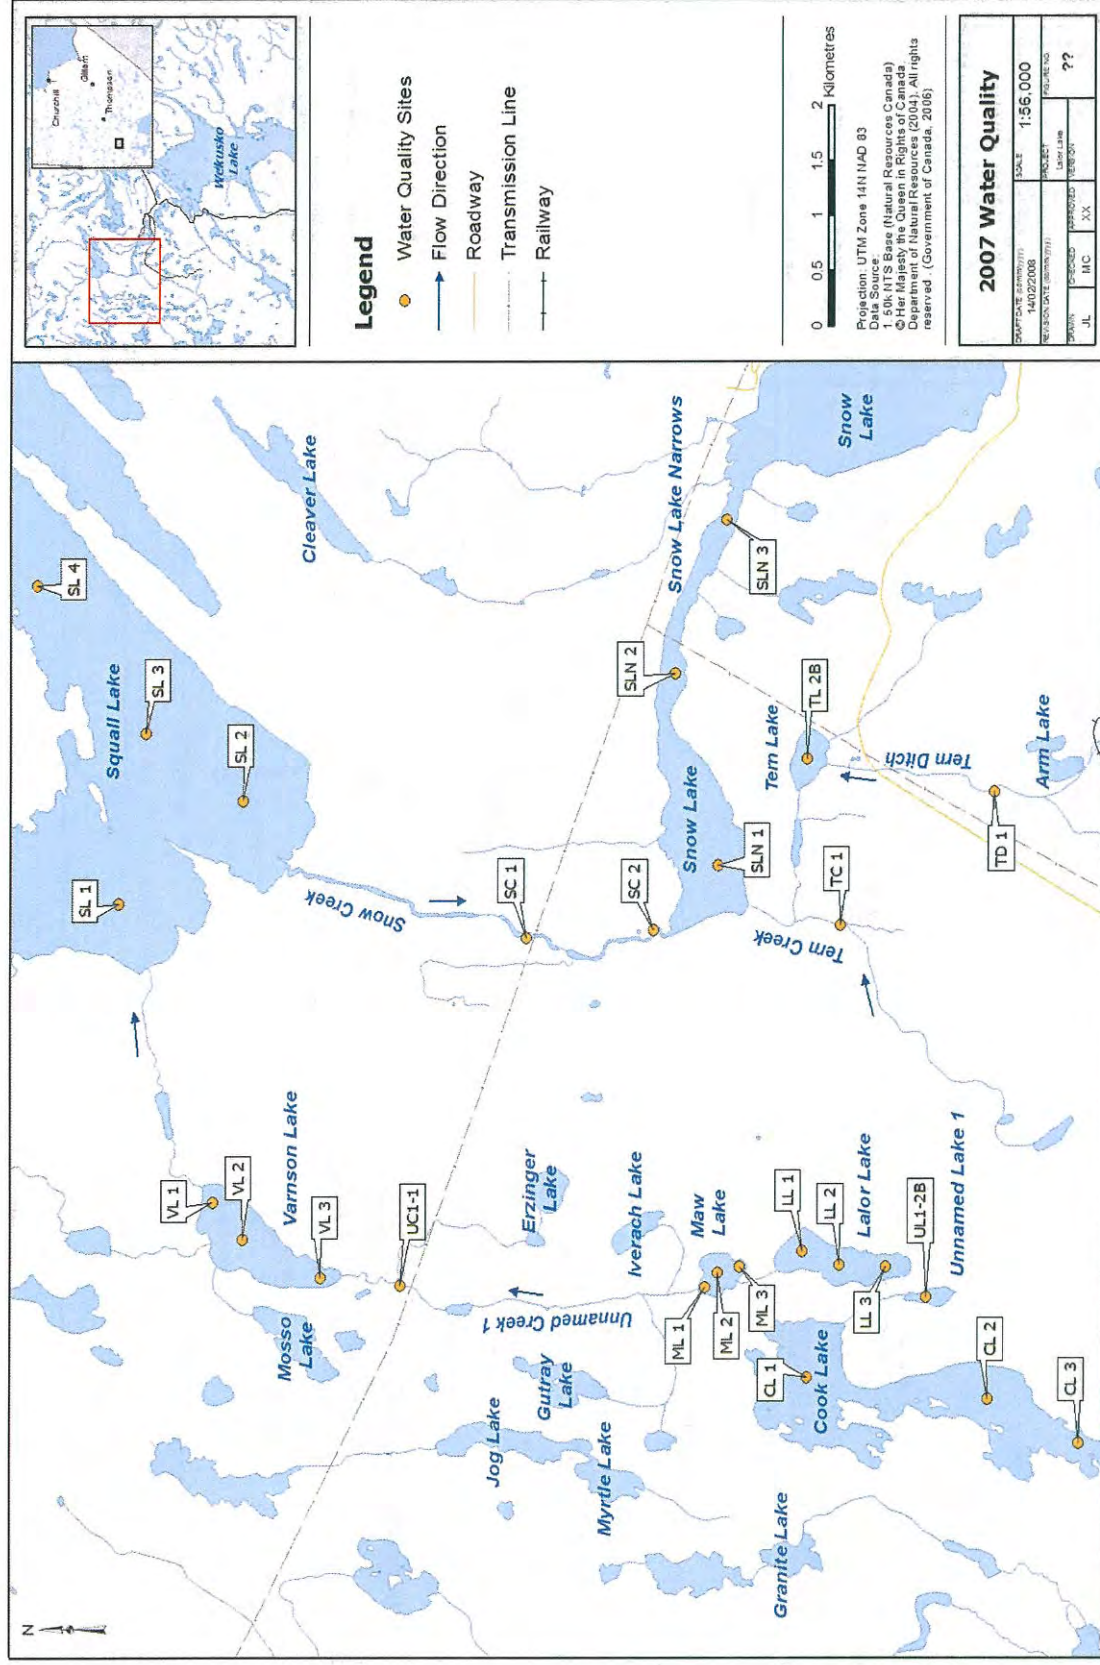
Figure 4. Water quality sampling sites in the Lalor Lake Study Area.

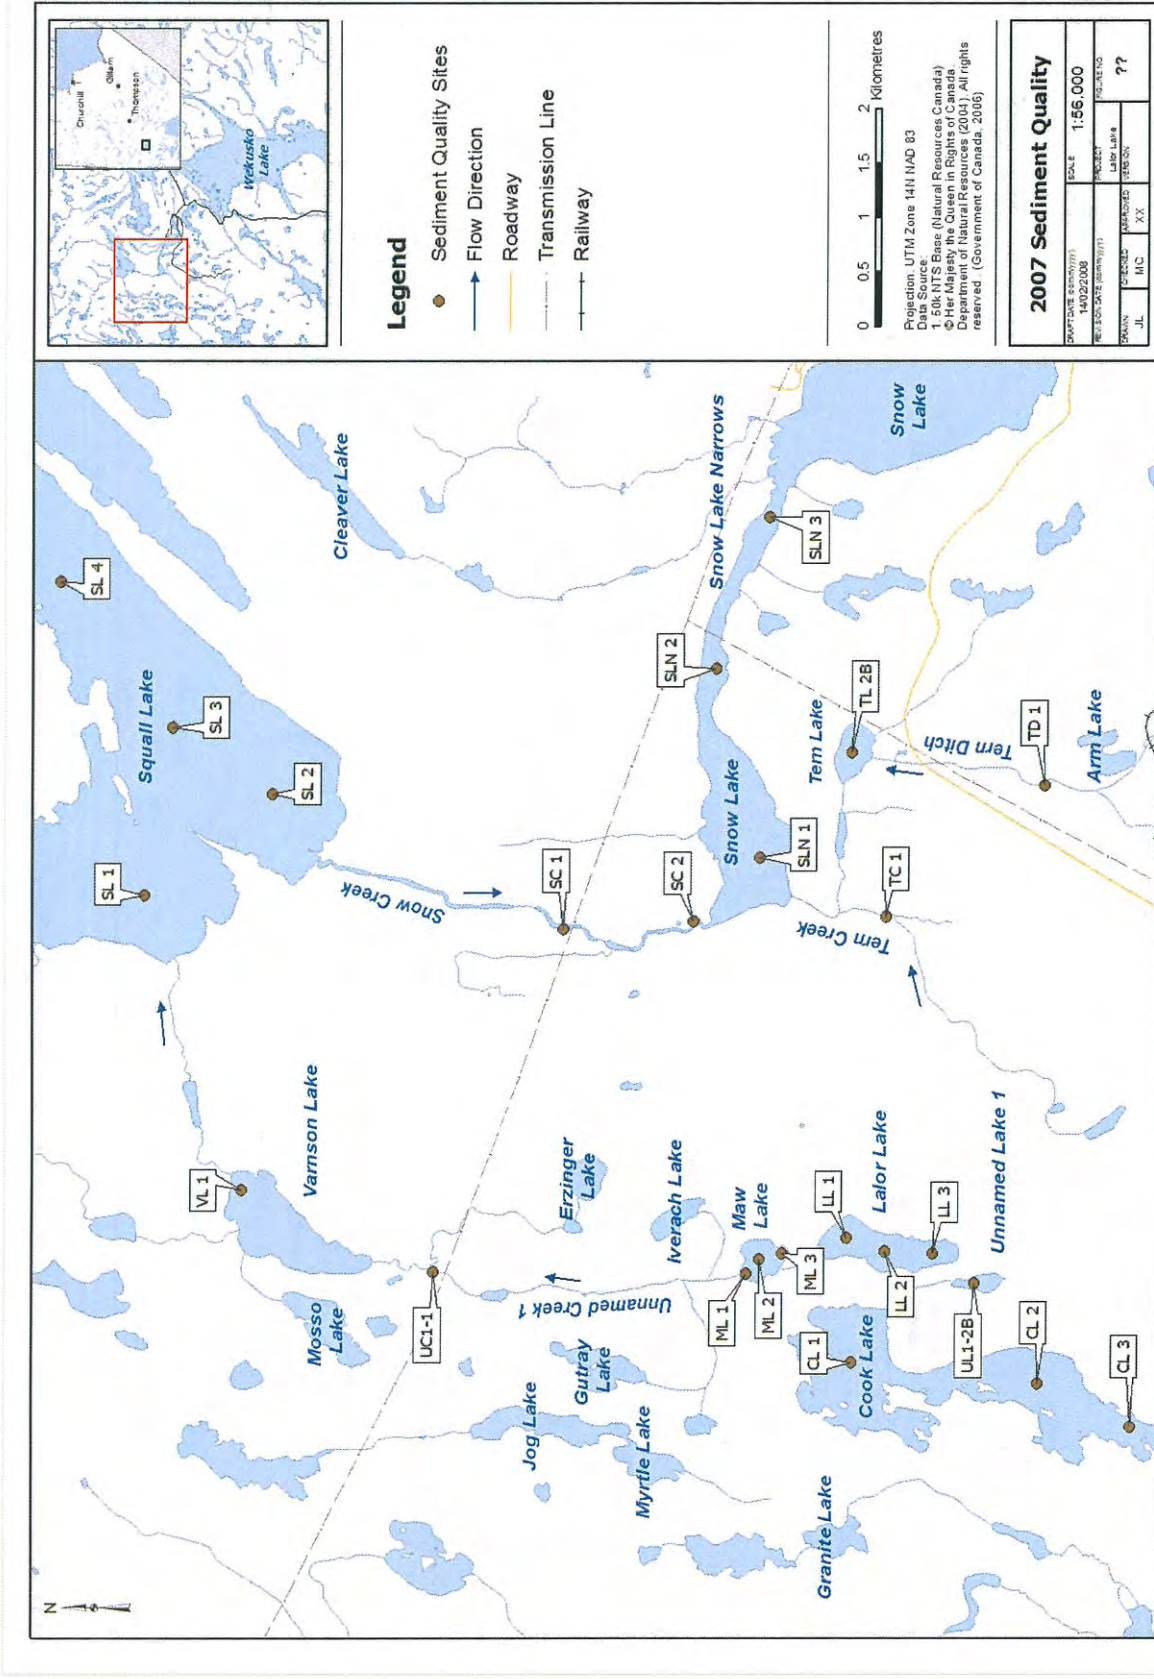
Figure 5. Sediment quality sampling sites in the Lalor Lake Study Area.

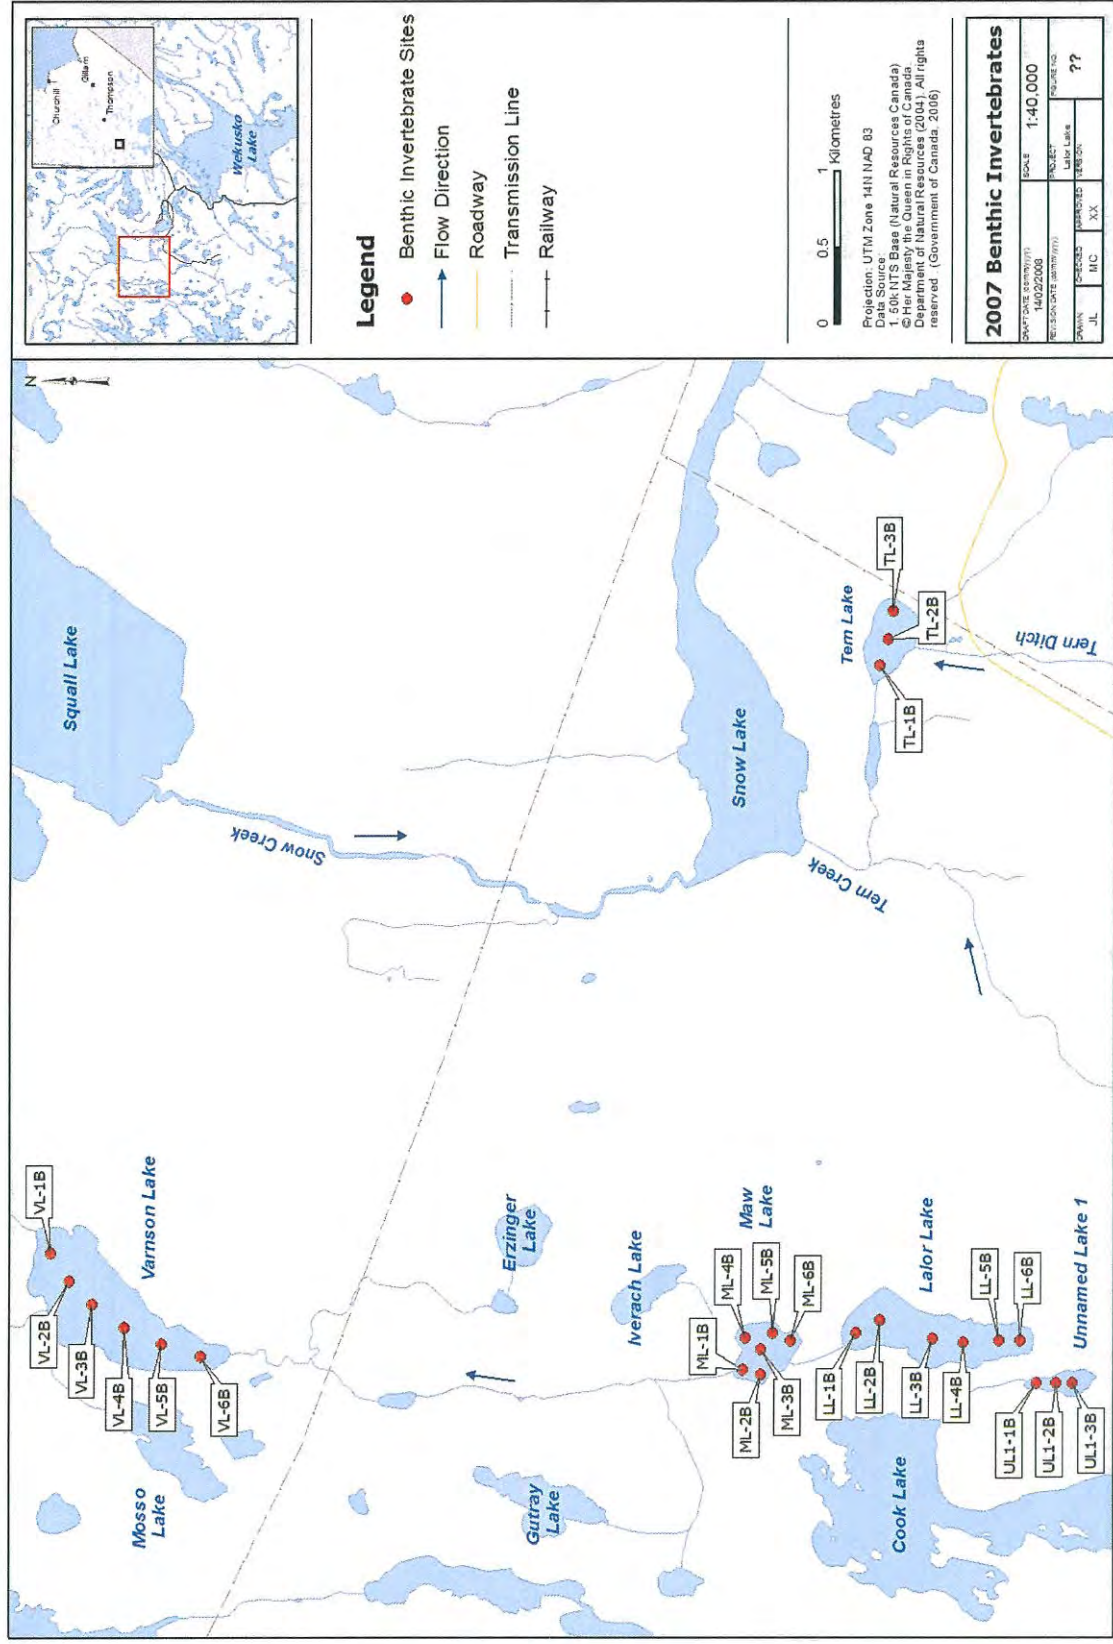
Figure 6. Benthic invertebrates sampling sites in the Lalor Lake Study Area.

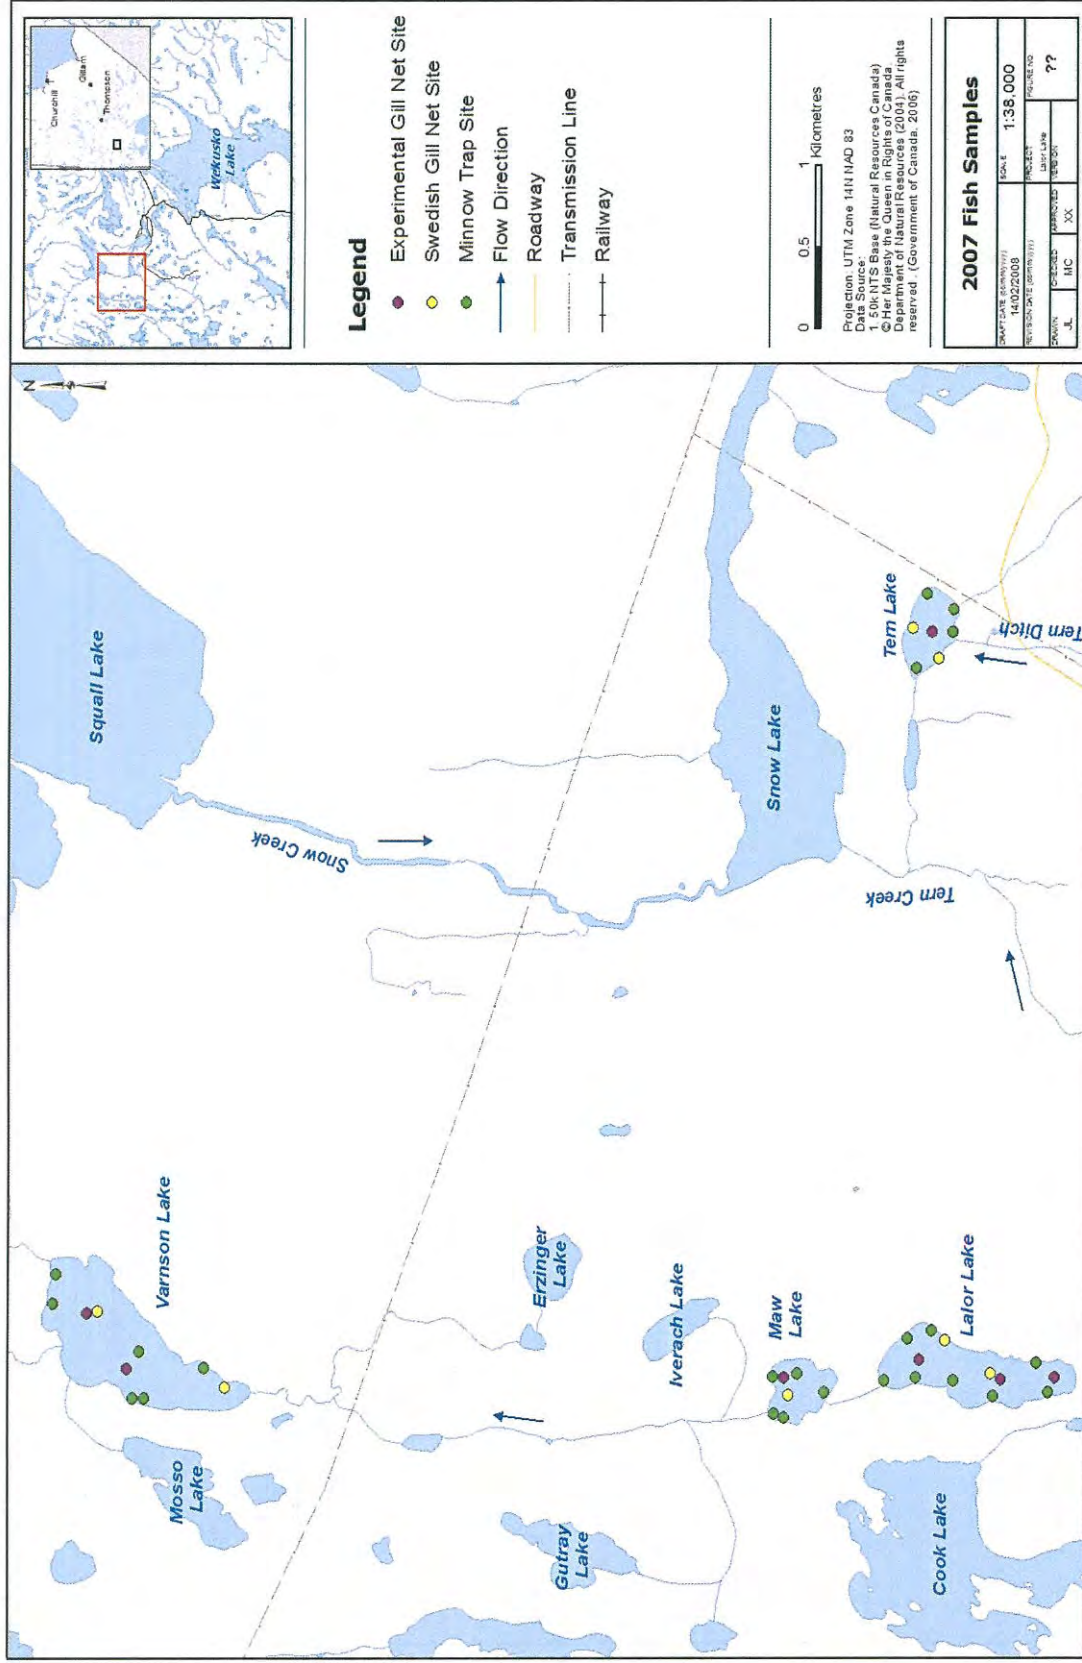
Figure 7. Fish collection sites in the Lalor Lake Study Area.

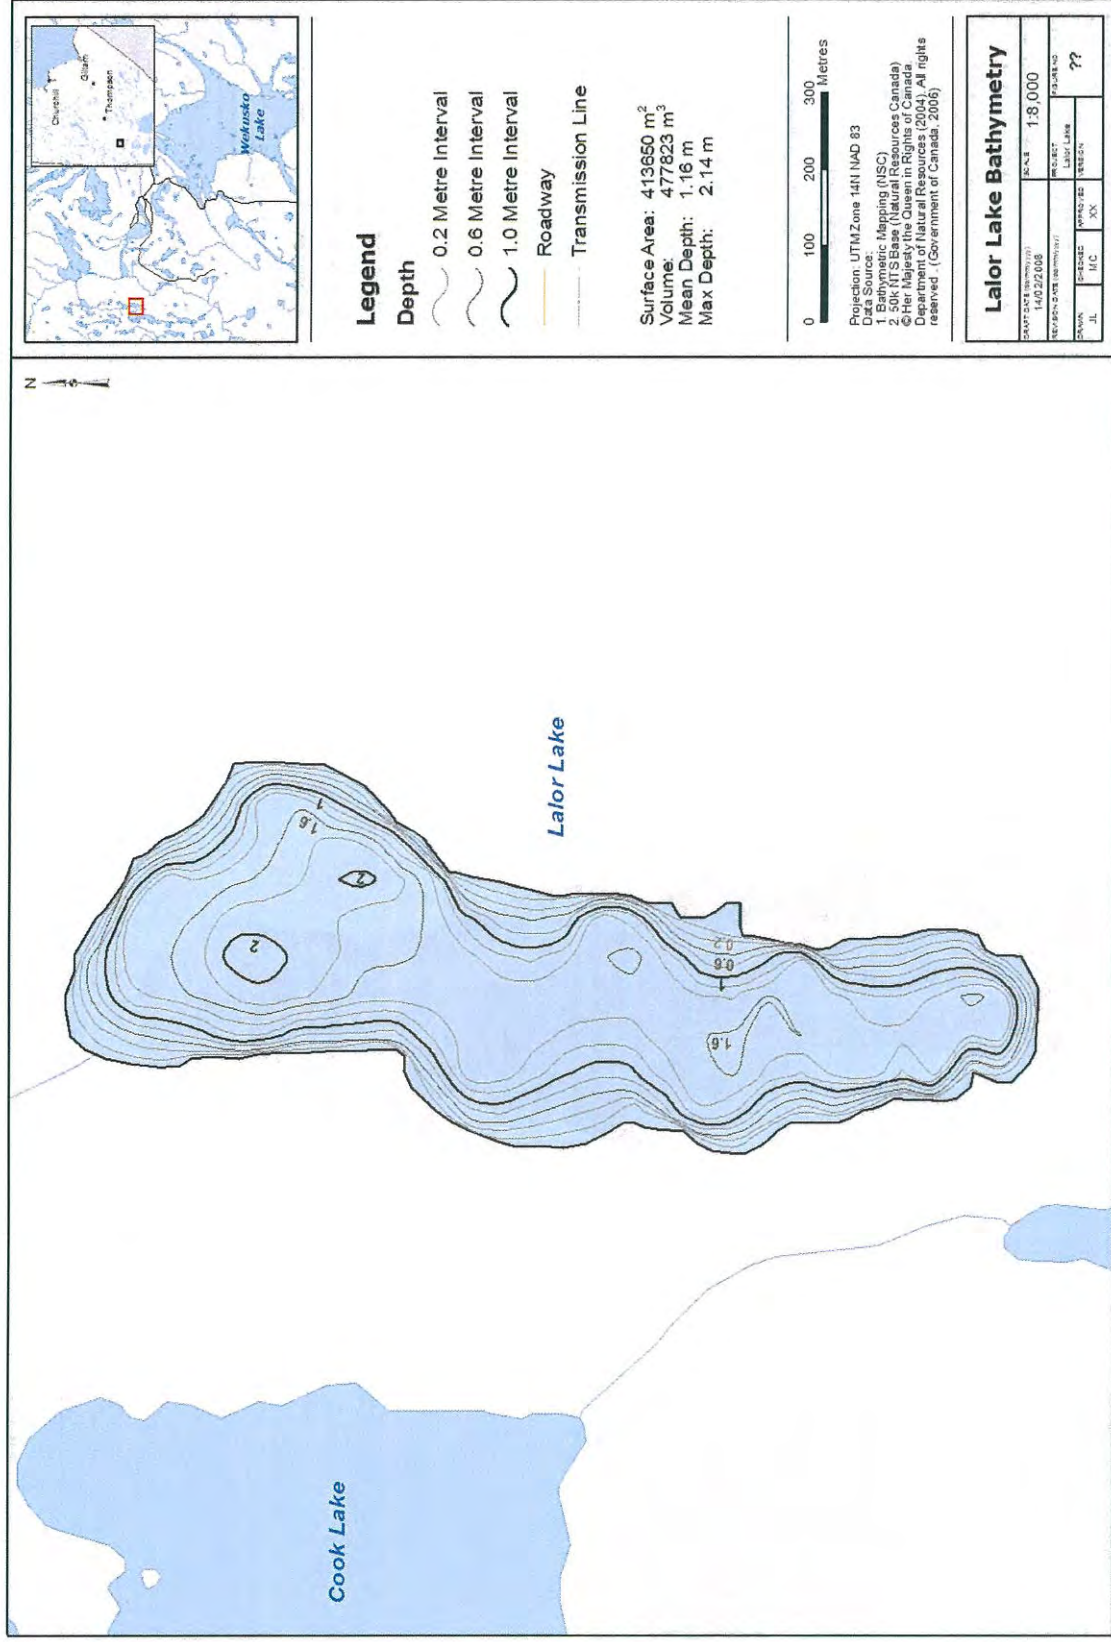
Figure 8. Lalor Lake bathymetric map.

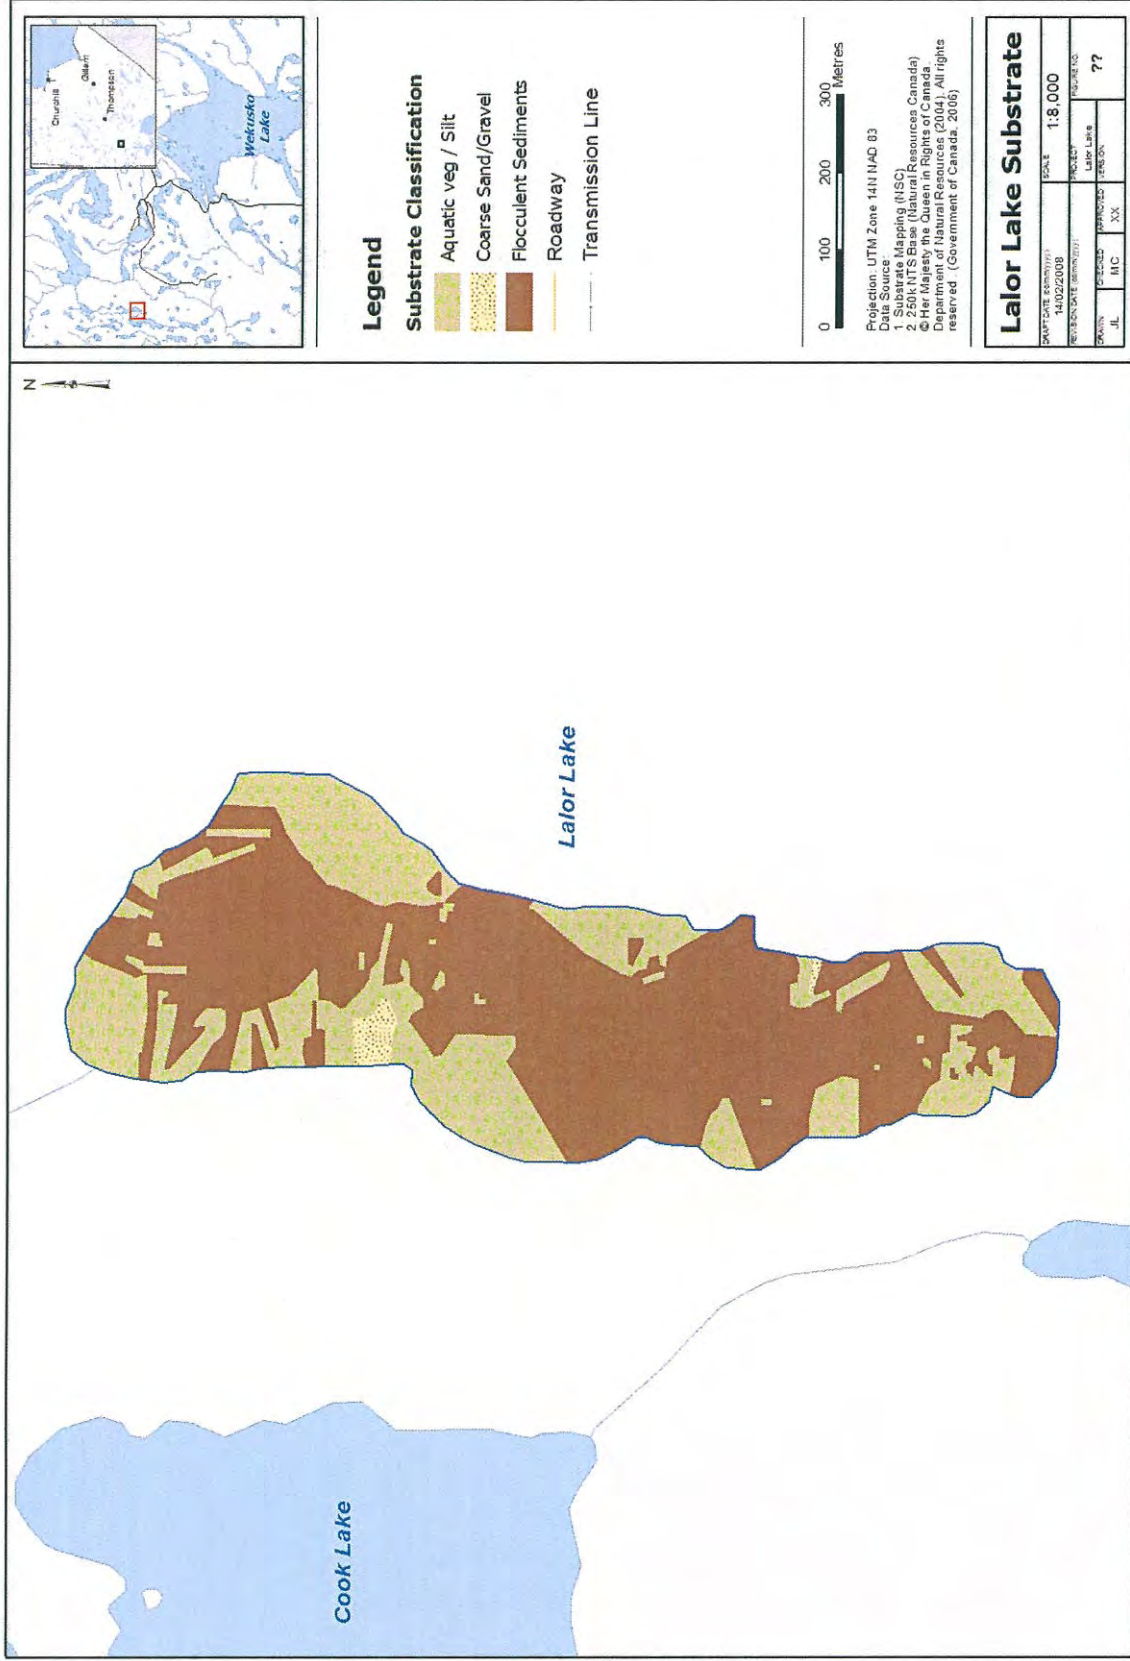
Figure 9. Substrate map of Lalor Lake.

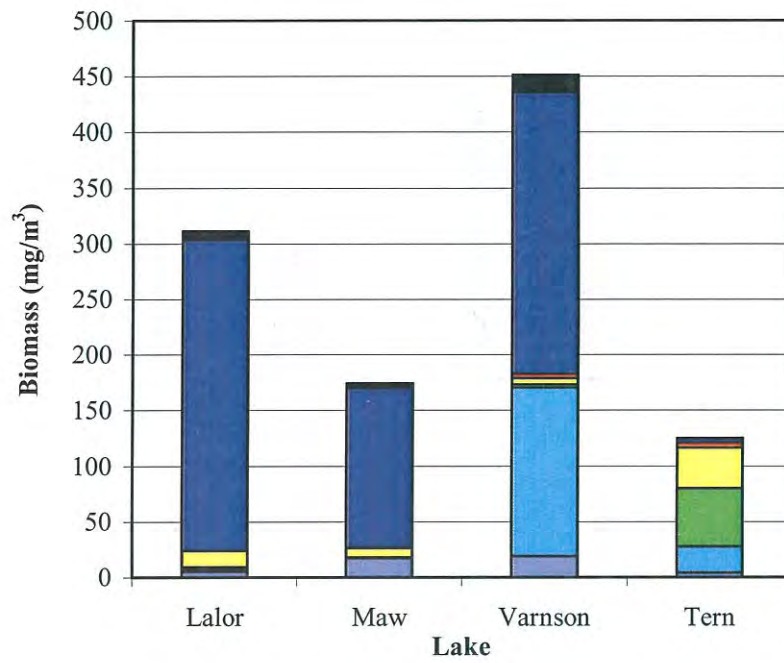
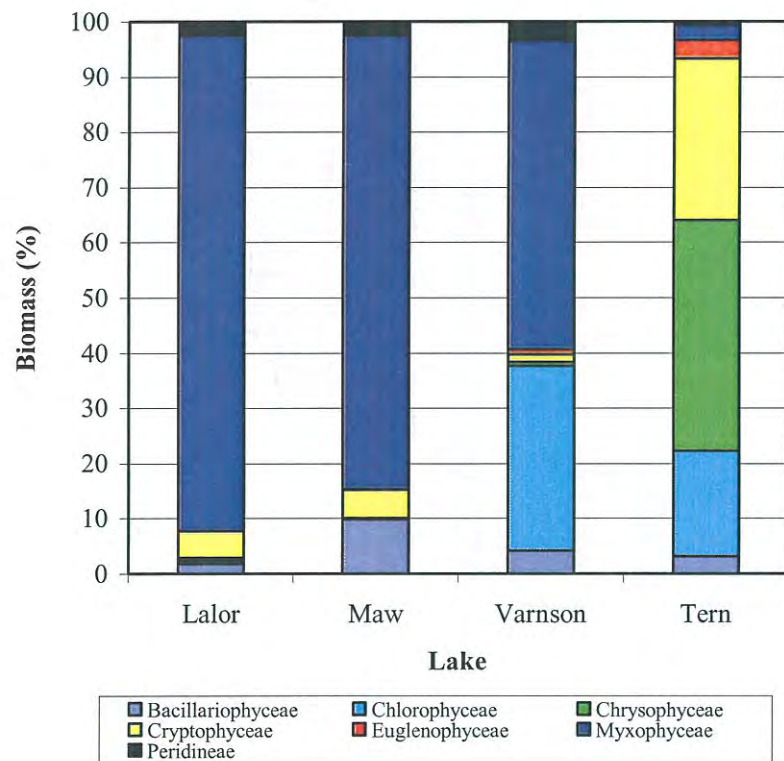
Figure 10. Phytoplankton species biomass (A) and relative abundance (B) in Study Area lakes.

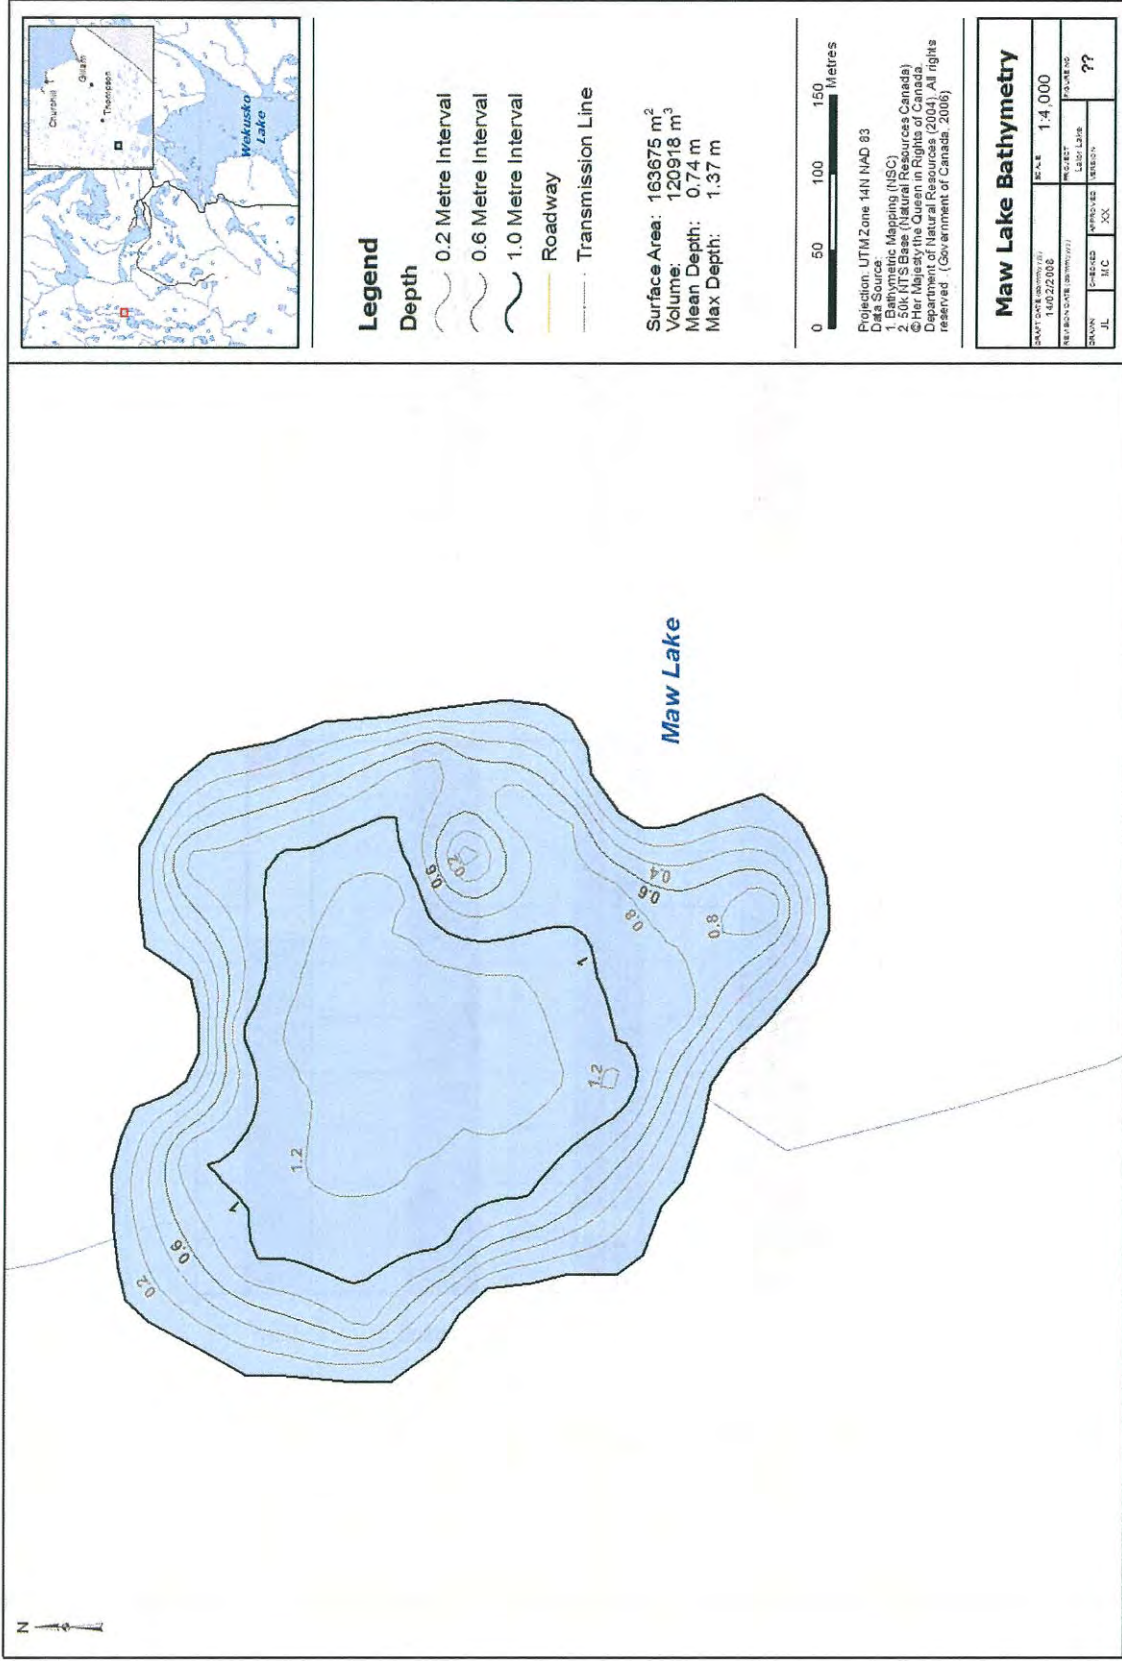
Figure 11. Maw Lake bathymetric map.

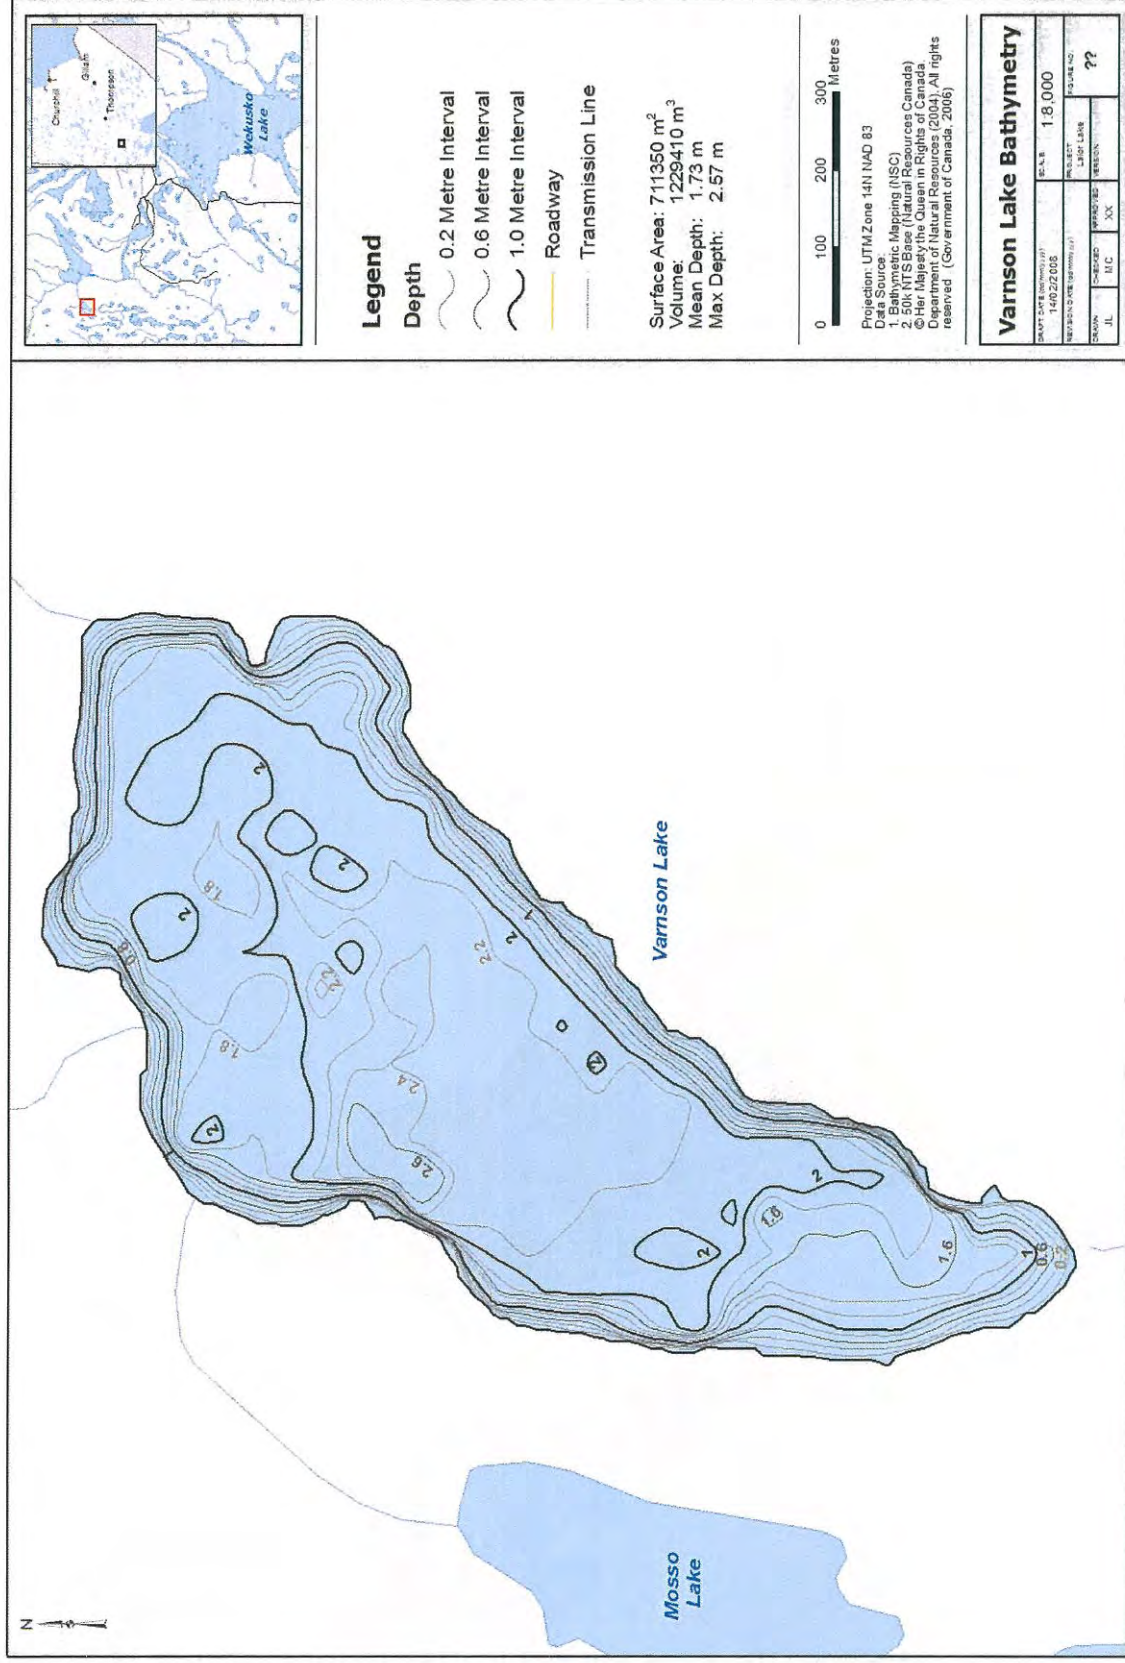
Figure 12. Varnson Lake bathymetric map.

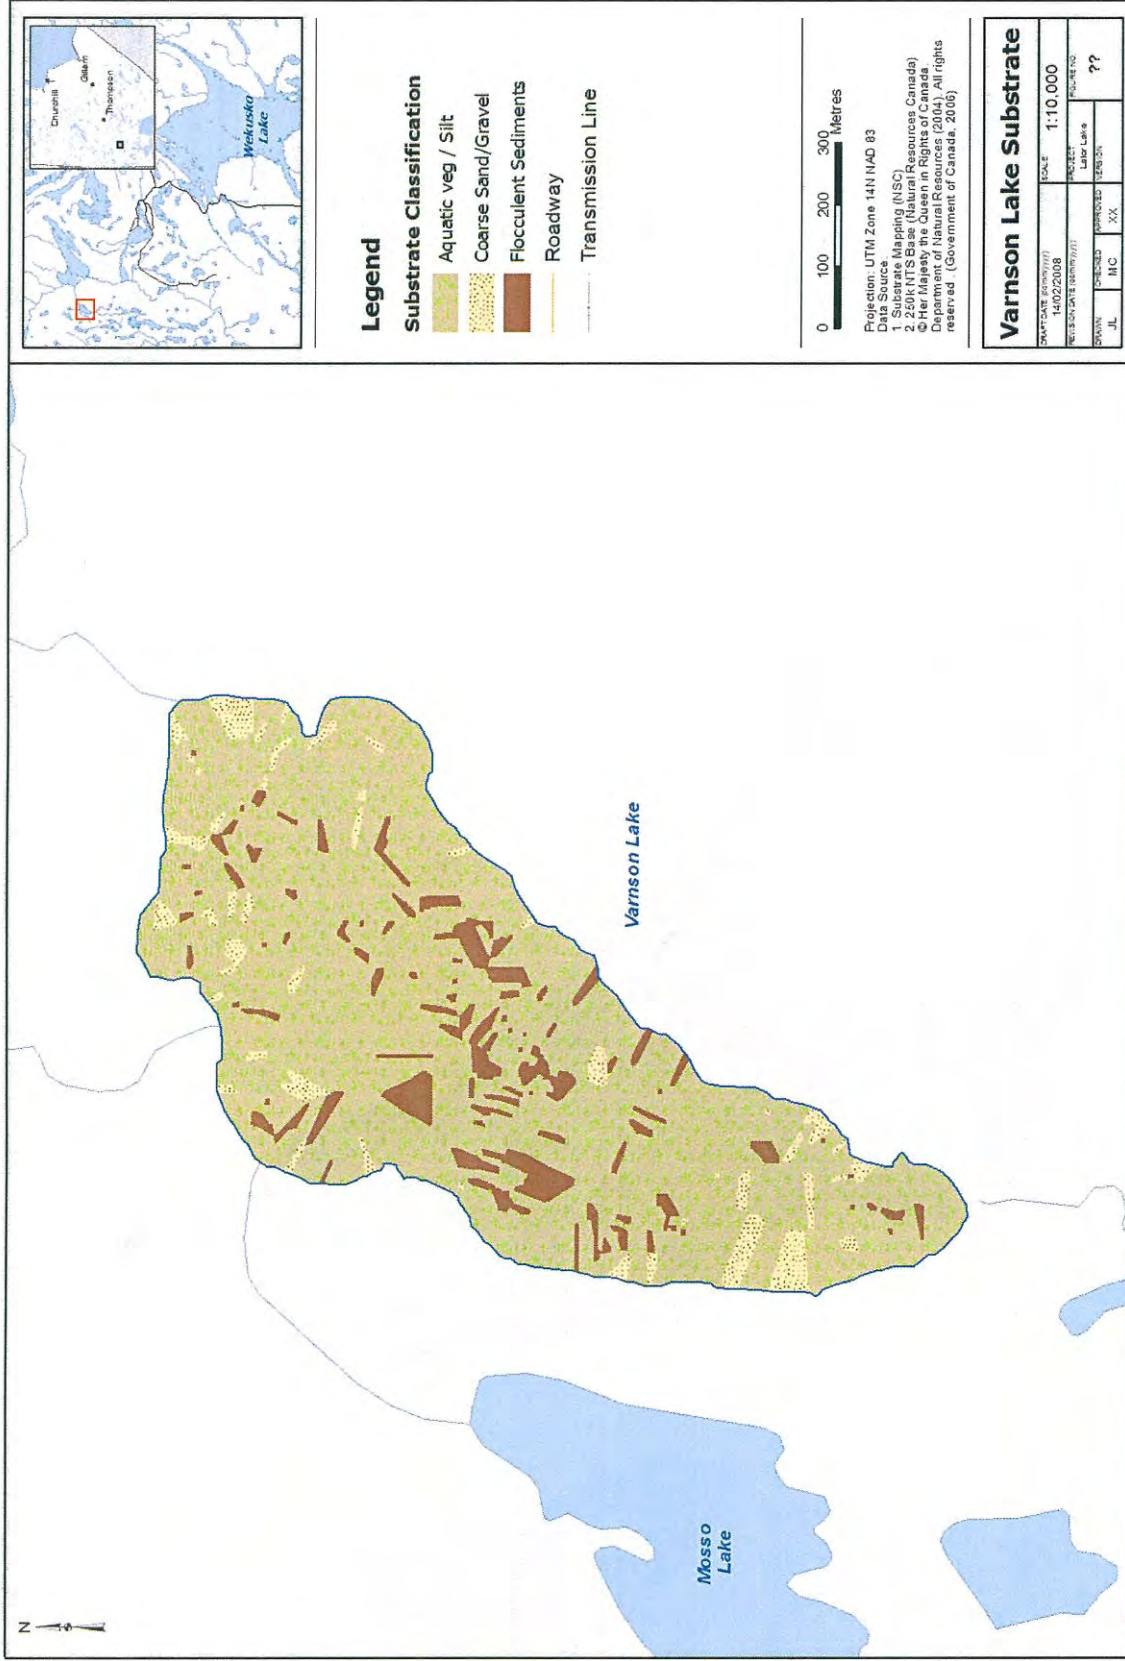
Figure 13. Substrate map of Varnson Lake.
