Figure 1. The Lalor Lake Study Area.

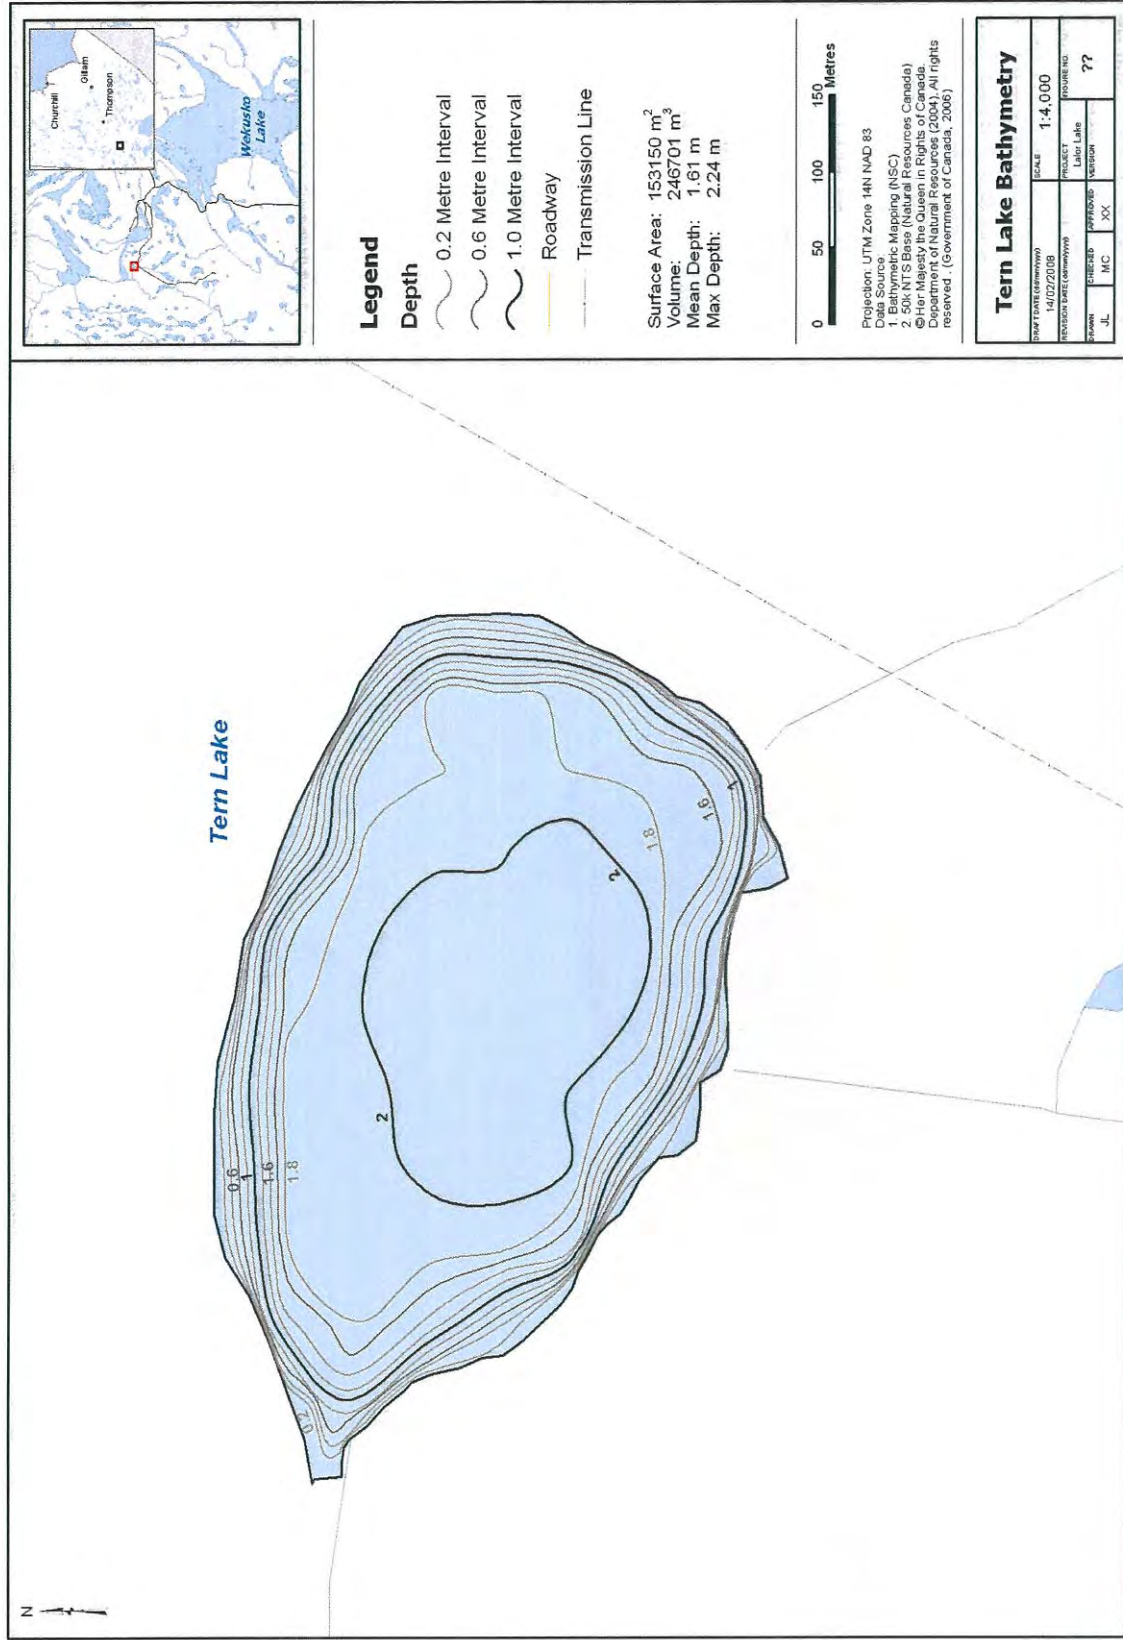
Figure 14. Tern Lake bathymetric map.

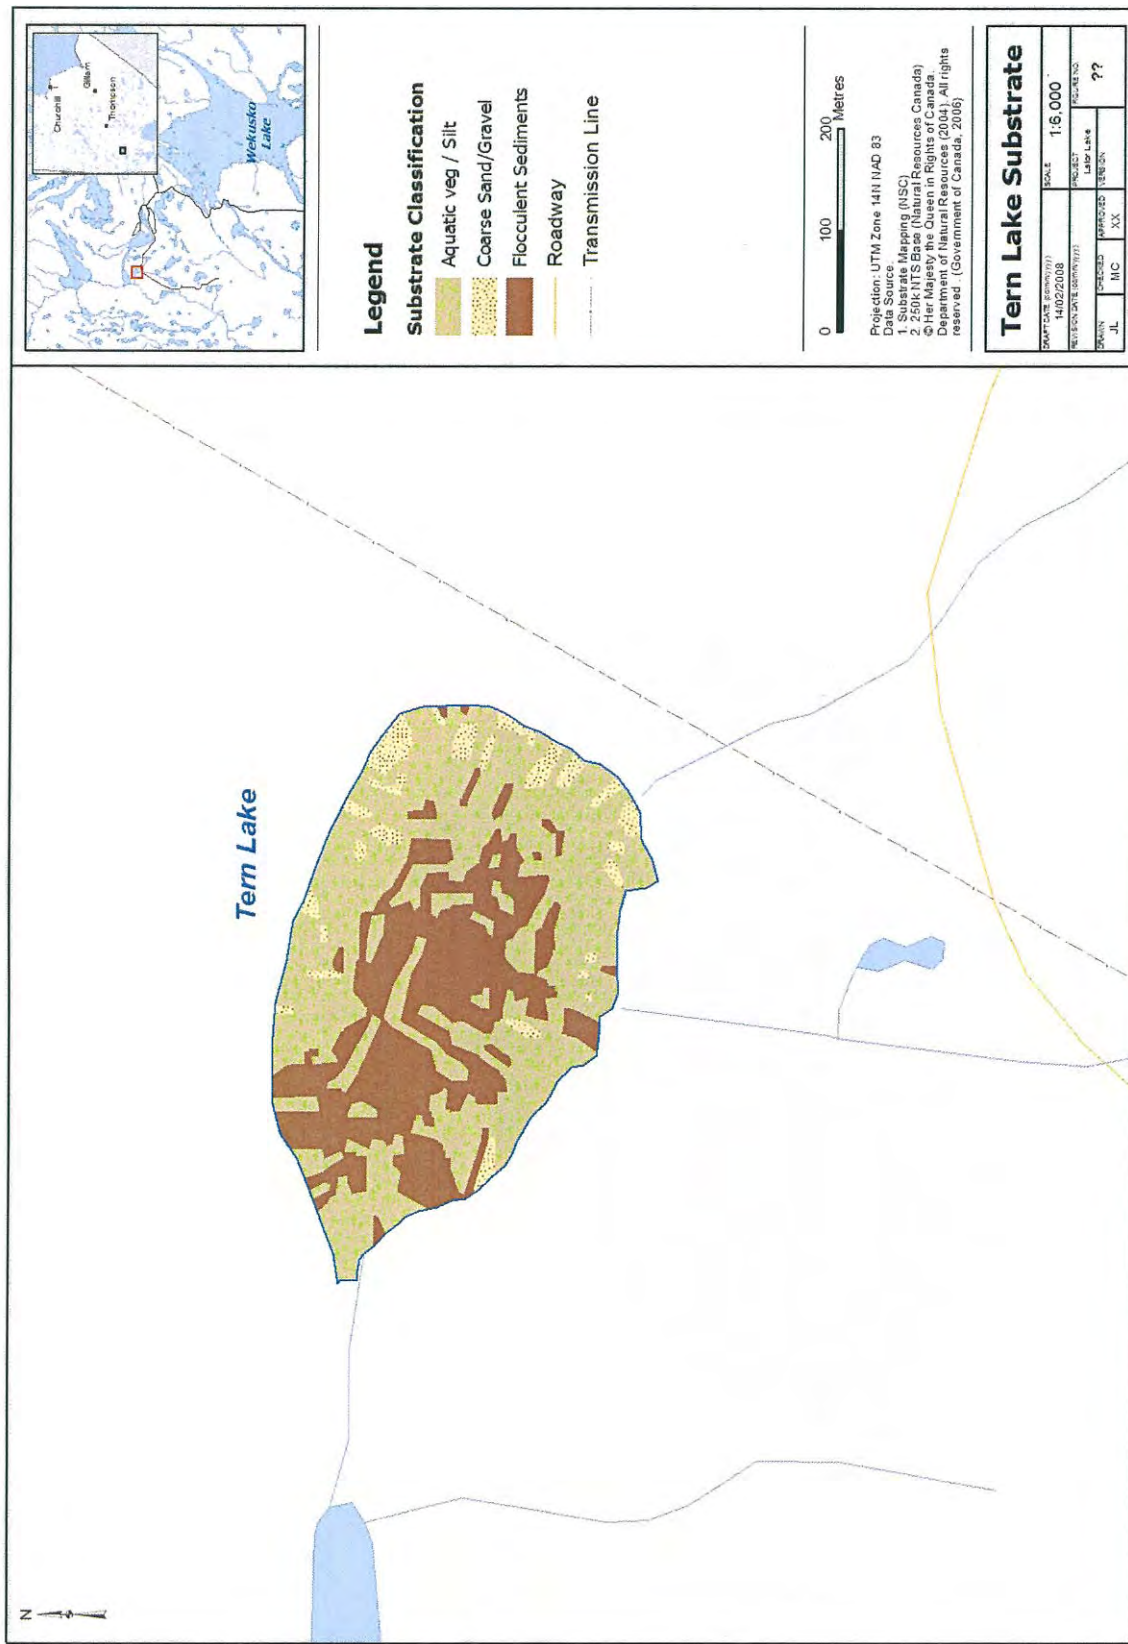
Figure 15. Substrate map of Tern Lake.
