Ruttan Mine Remediation

Orphaned and Abandoned Mine Site Rehabilitation Program

UPDATE

Tailings Management Area (TMA) Capping and Drainage Cut-off Construction

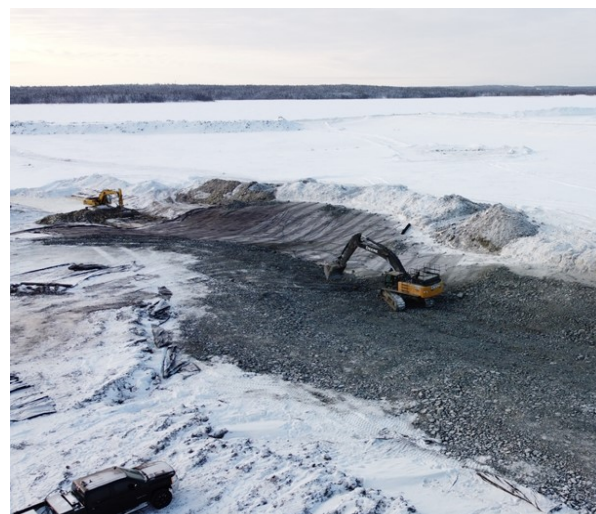
Excavators placing rockfill to stabilize slopes in the tailings management area.

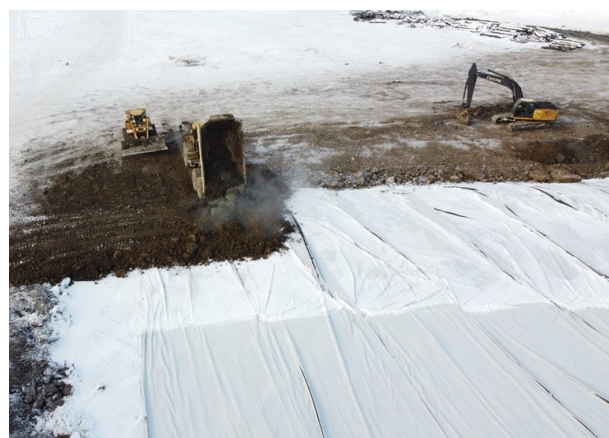
Rock truck and dozer spreading clay fill on a stabilized subgrade

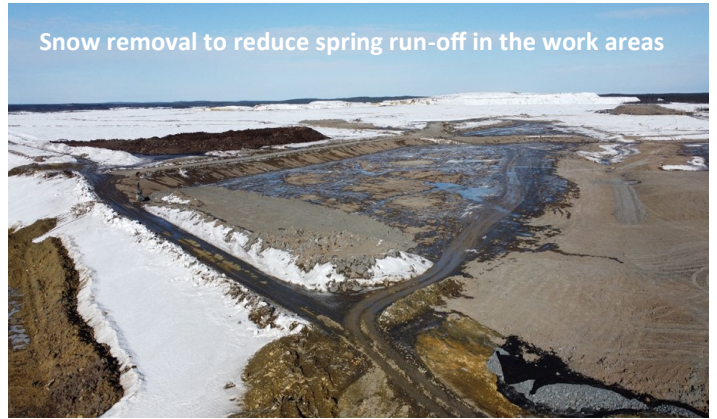
Snow removal to reduce spring run-off in the work areas

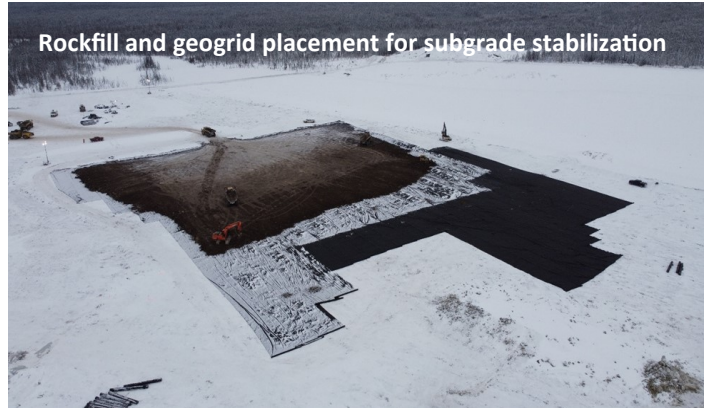
Rockfill and geogrid placement for subgrade stabilization

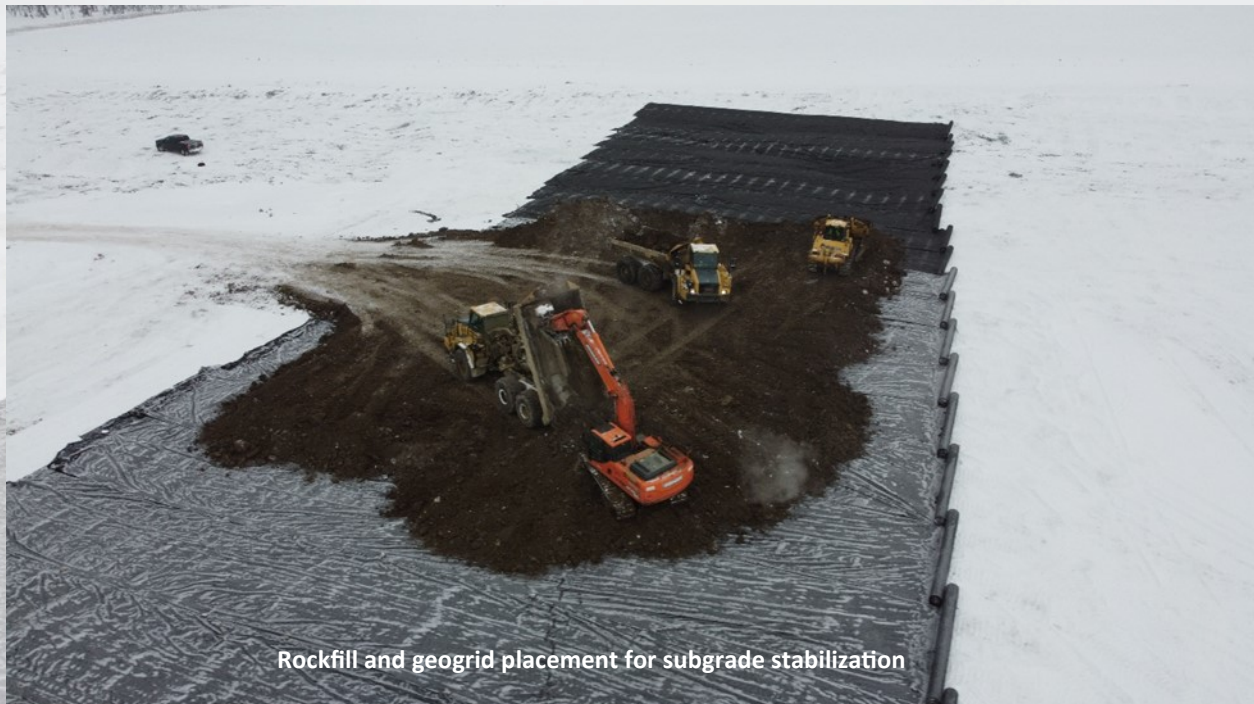
Rockfill and geogrid placement for subgrade stabilization
